ORCHARD AVENUE CORRIDOR STUDY

08-01-2022

Rev.1

**COLLINS
ENGINEERS^{PC}**

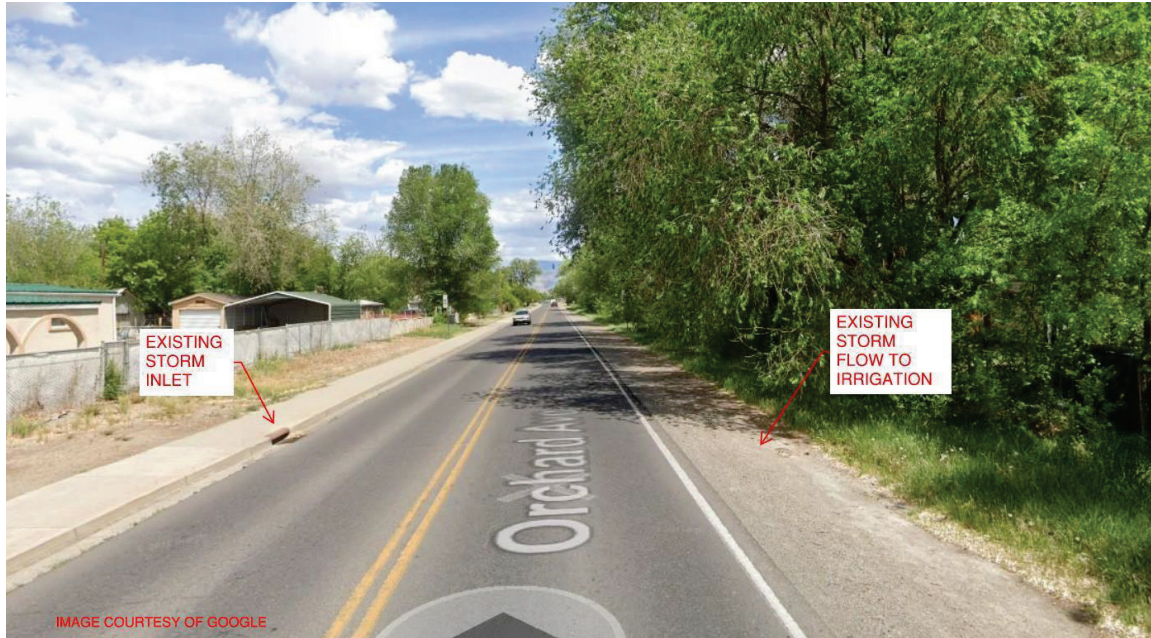
Figure 34-Orchard Surface Drainage

- ▶ The proposed design in this area includes adding an attached walk to the south side of Orchard Road, both to improve pedestrian access on the south side of the road and to control storm runoff from entering the irrigation ditch. Additional curb inlets are proposed on the south side of the roadway crown adjacent to the existing inlets. In this flat area, proposed roadway design shall meet the Mesa County minimum slope of 0.5%, with high points introduced between the existing storm drains to promote positive surface drainage.

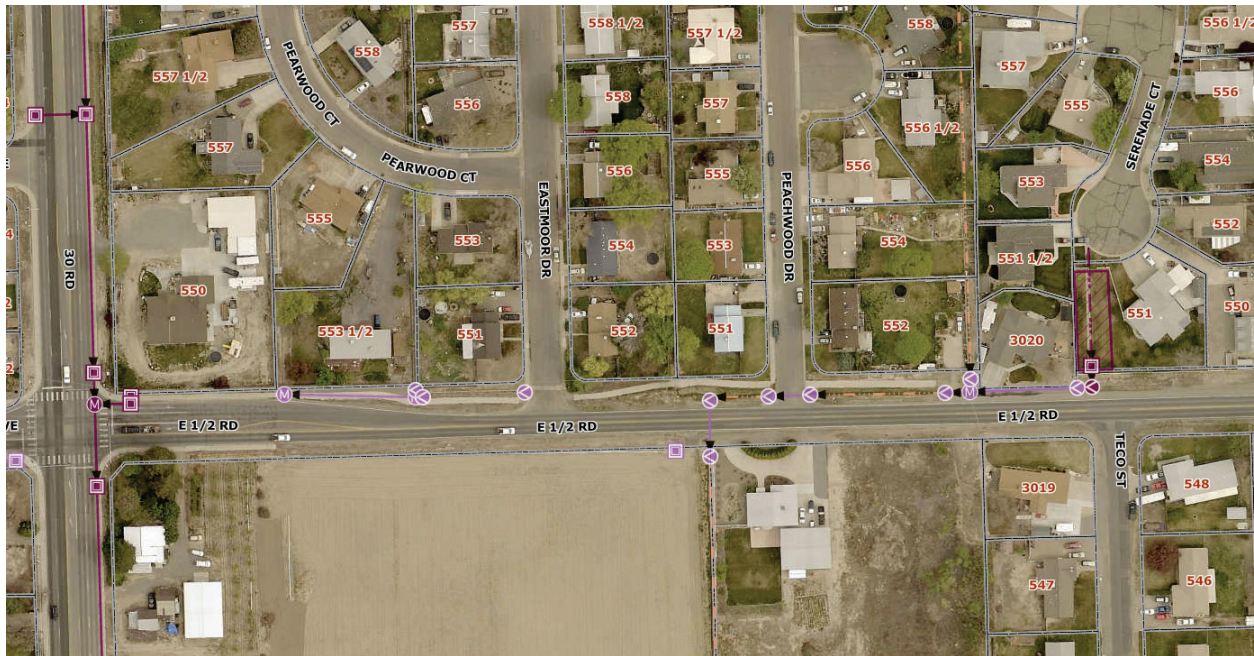
Figure 35: Stormwater drains along Orchard Avenue

- ▶ From 30 Road east to Peachwood Drive, there is a slope at approximately 0.5% from east to west. Existing stormwater in this area drains from the roadway into open irrigation ditches on both sides of the road. The irrigation ditch on the north side collects water from an irrigation ditch running through the neighborhood south from Bookcliff Avenue as well as storm runoff from Serenade Court. This irrigation line crosses Orchard Road between Peachwood and Eastmoor Drives and is shown terminating in that location per the City GIS. Drainage from the proposed roadway in this section should be collected within the roadway prism and directed to the existing inlets at the 30 Road intersection for collection in the storm sewer system.

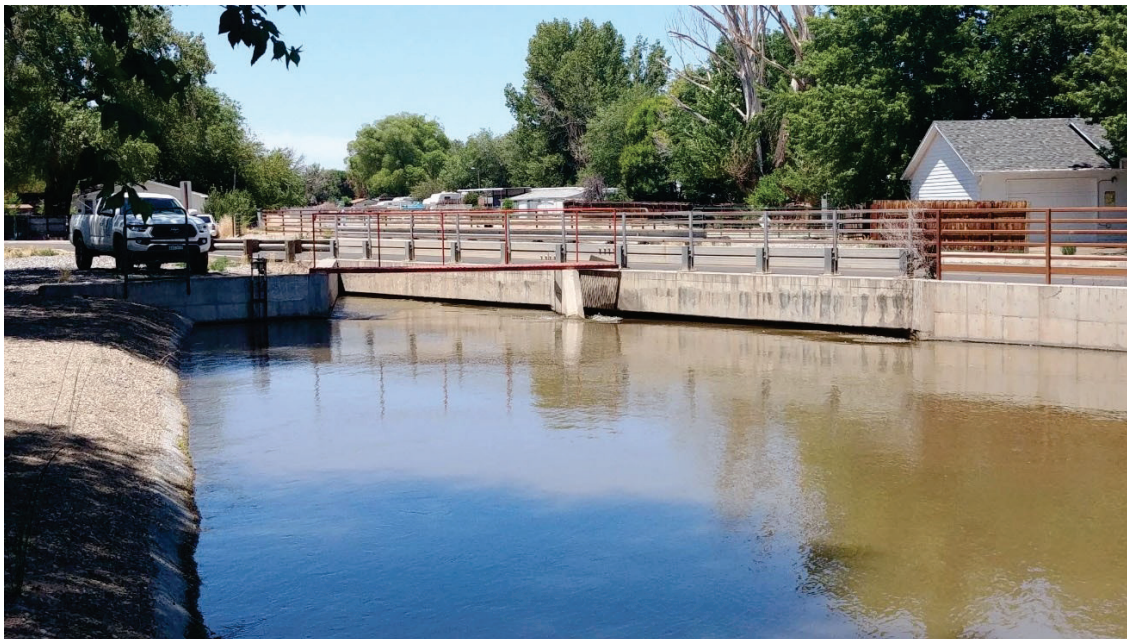
Figure 63: Grand Valley Canal Box culvert at Orchard Avenue, looking west-northwest

Orchard Avenue crosses the Grand Valley Canal, as shown in Figure 51, and Lewis Wash, as shown in Figure 52. We understand the new structure (Mesa County Structure 29.8) may consist of a single or two-span precast, prestressed concrete slab bridge with either a 46-foot or 56-foot wide roadway section. The existing Lewis Wash concrete box culvert structure will be replaced with a two-cell box culvert (Mesa County Structure 31.01). Detailed plans for structure replacements, detailed structural loads, changes in grade and embankment heights are unknown at the time of this report.

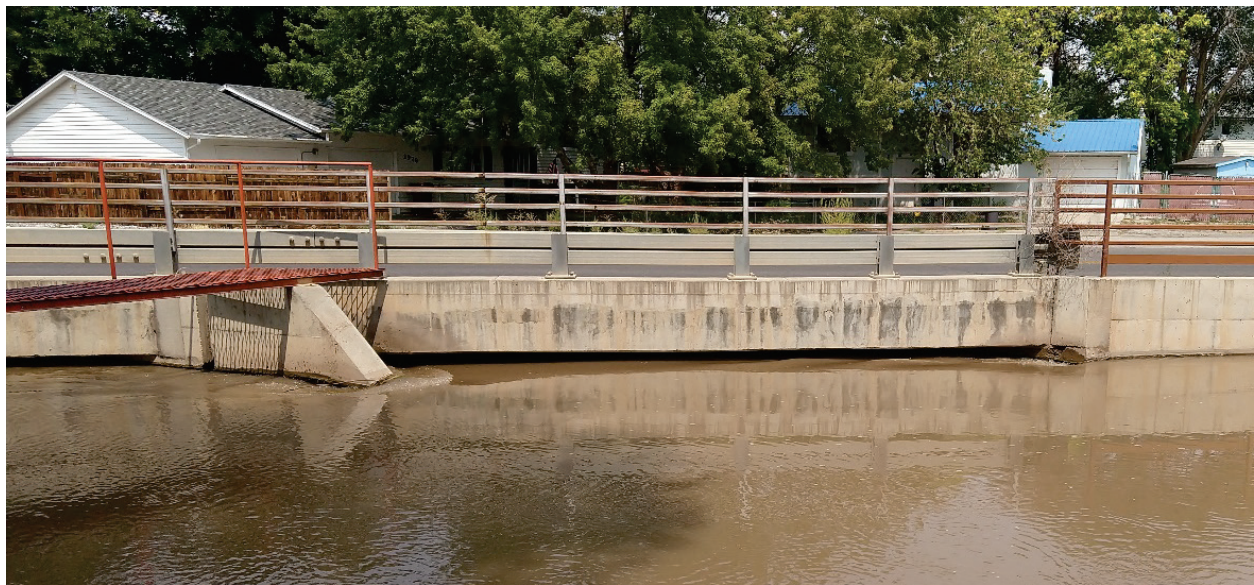
Figure 67: Existing Freeboard

It is worth noting the lack of freeboard between the water surface and low chord of the bridge during the time of the survey at an estimated flow of 555 cfs. There was a difference of less than 4 inches between the water surface level just before the bridge and the low chord as shown in **Figure 55**, below. The lack of freeboard is also visible when the canal is shut off as the high-water line is within an inch of the low chord as shown in **Figure 56**, below.

Observed at Orchard Avenue Bridge in September 2021

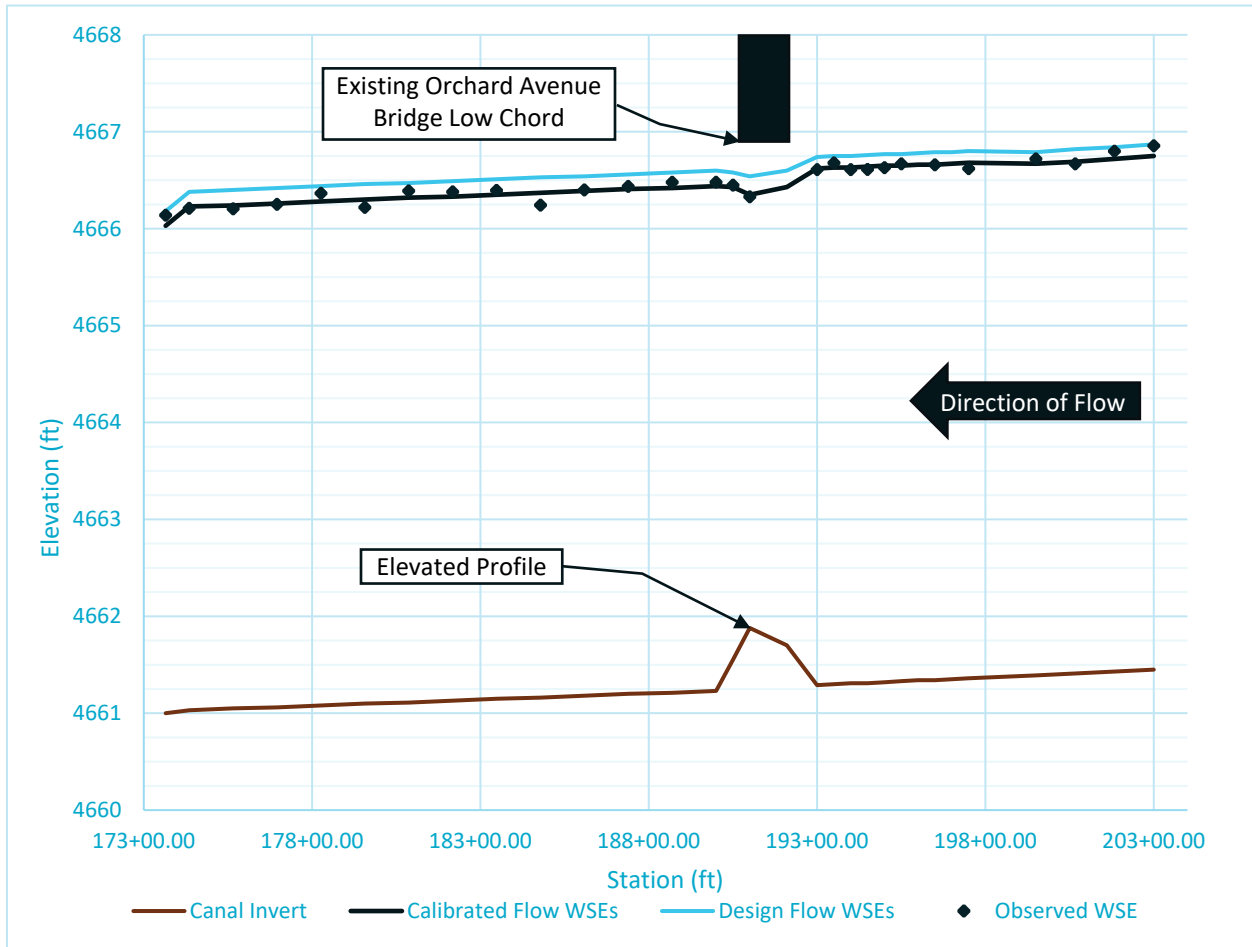
Figure 69: Calibrated Model Results

The HEC-RAS model was run with updated geometry and flows and the resulting WSEs were compared to the observed WSEs from the survey. The model appeared to accurately represent the surveyed WSE utilizing the model parameters described above. The close match of WSE between the model and the survey are demonstrated in **Figure 57** below.

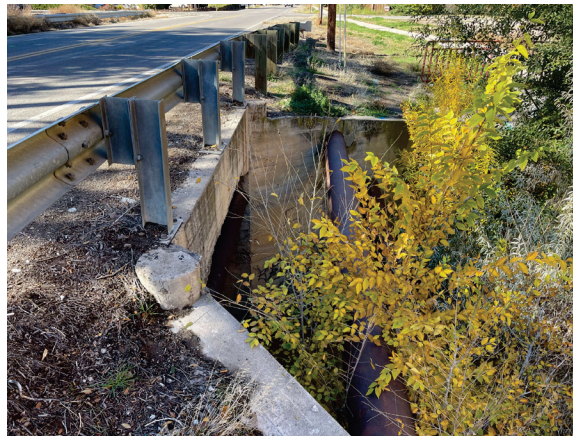
The project includes: the removal of an existing 12'-2" W x 12'-8"H cast-in-place concrete culvert with wingwalls (Photo 1); replacing the box culvert with 2- 14'W x 12'H reinforced concrete box culverts with increased flood capacity, and the widening to Orchard Avenue. The roadway

Photo 1 – Upstream End of Existing Culvert Structure at e 1/2 Road

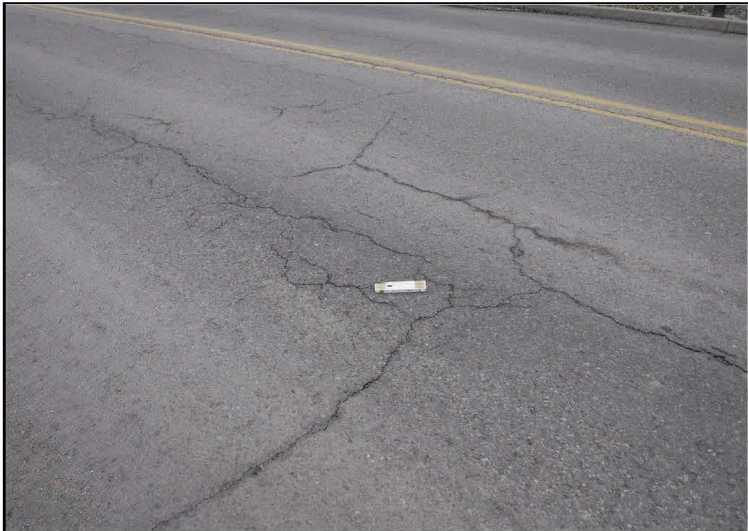
Map cracking in asphalt on top slab

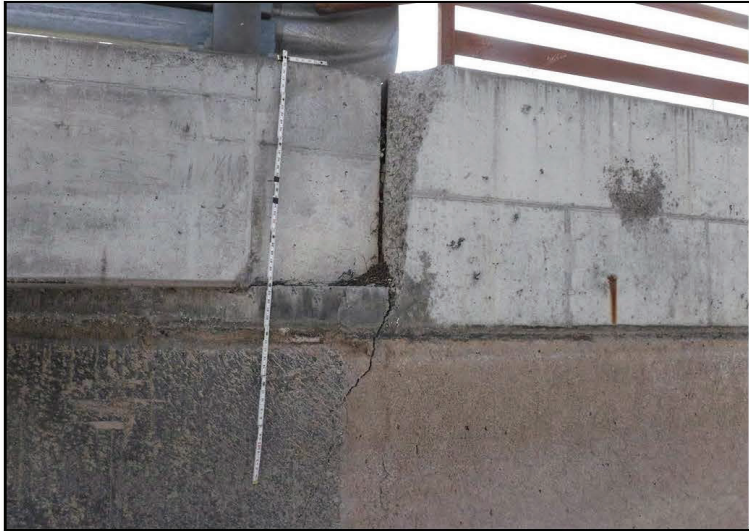
Spall and vertical crack in northwest wingwall

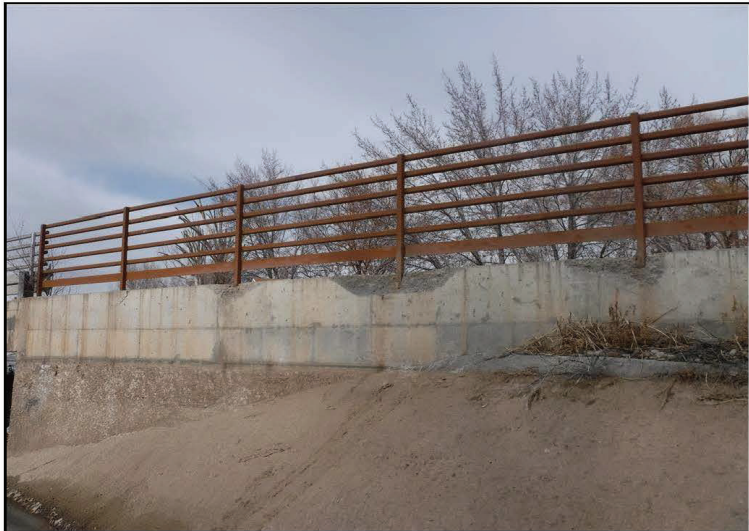
Spalls in southeast wingwall at rail posts

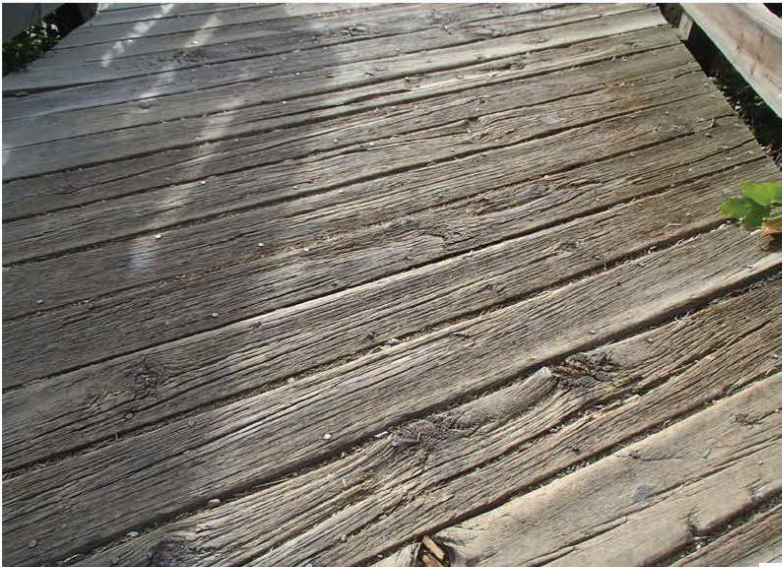
Running plank condition

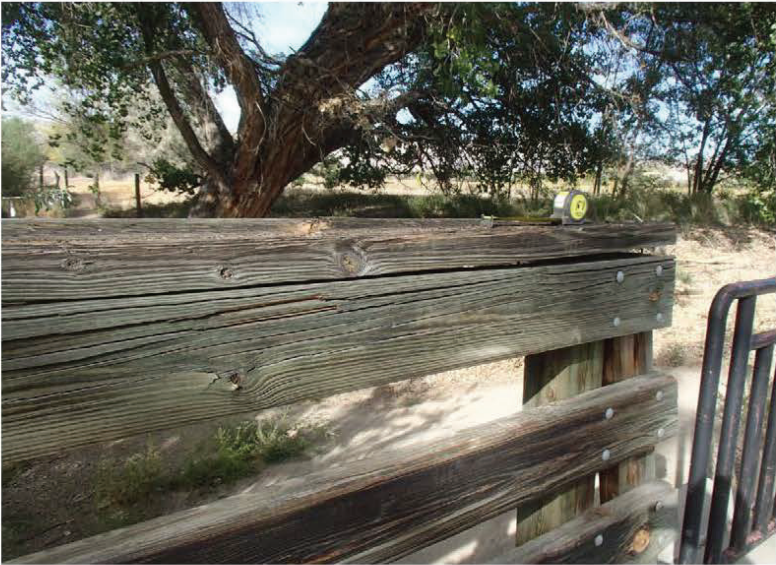
Cracked and weathered rail at northwest corner

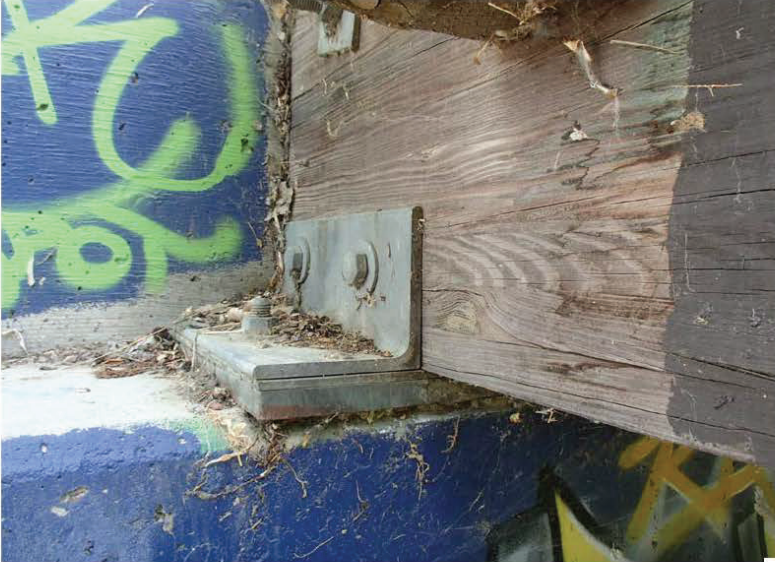
Typical bearing condition

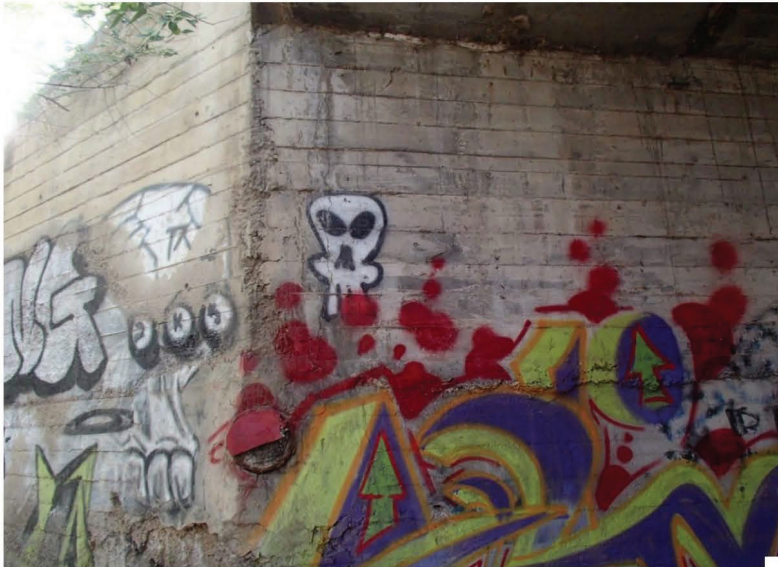
Crack with water leaking at southwest corner

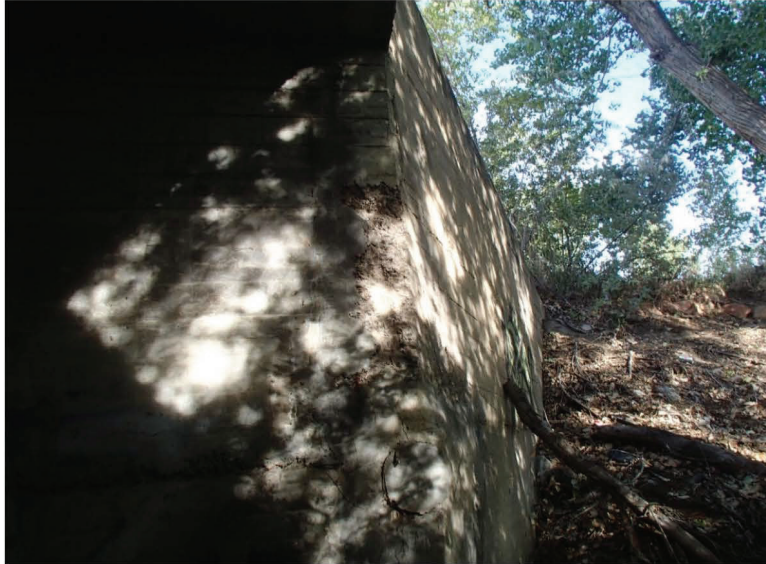
Spalling on southeast wingwall
