Grand Valley River Corridor Initiative

Fluvial Hazard Zone Mapping Addendum for the Colorado River and Gunnison River in the Grand Valley, Mesa County, Colorado

March 2023

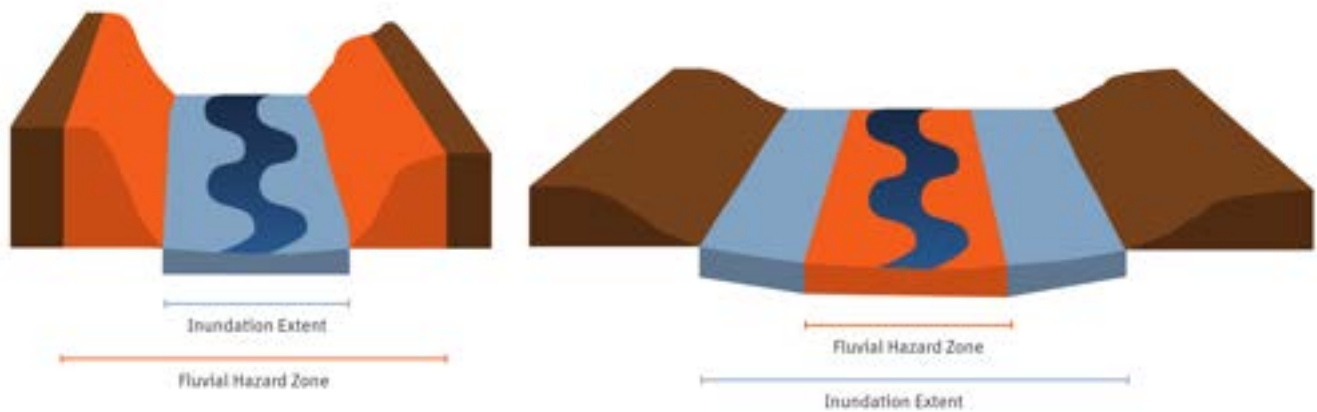
Figure 1-1: Comparison of the inundation extent (e.g., FEMA-defined floodplain) and Fluvial Hazard Zone for two different types of stream systems. On the left, the FHZ extends some distance into the erodible valley margins and therefore encompasses more than a FIRM would. On the right, the extent of floodplain inundation (or the regulatory floodplain) is wider than the area where fluvial hazards are expected. Figure adapted from Blazewicz et al. 2020.

beneath or adjacent to floodwaters is going to change either incrementally or dramatically as the area is exposed to energy, water, sediment, and debris during a flood. FHZ mapping is not directly tied to hydrologic statistics, specific storms, or runoff events and is not associated with a probability of occurrence. FHZ maps may not identify areas susceptible to standing water or very low energy flowing or pooling water, or groundwater upwelling or seepage. Features of Flood Insurance Rate Maps (FIRMs) and FHZ maps are shown below (from Blazewicz et al., 2020).

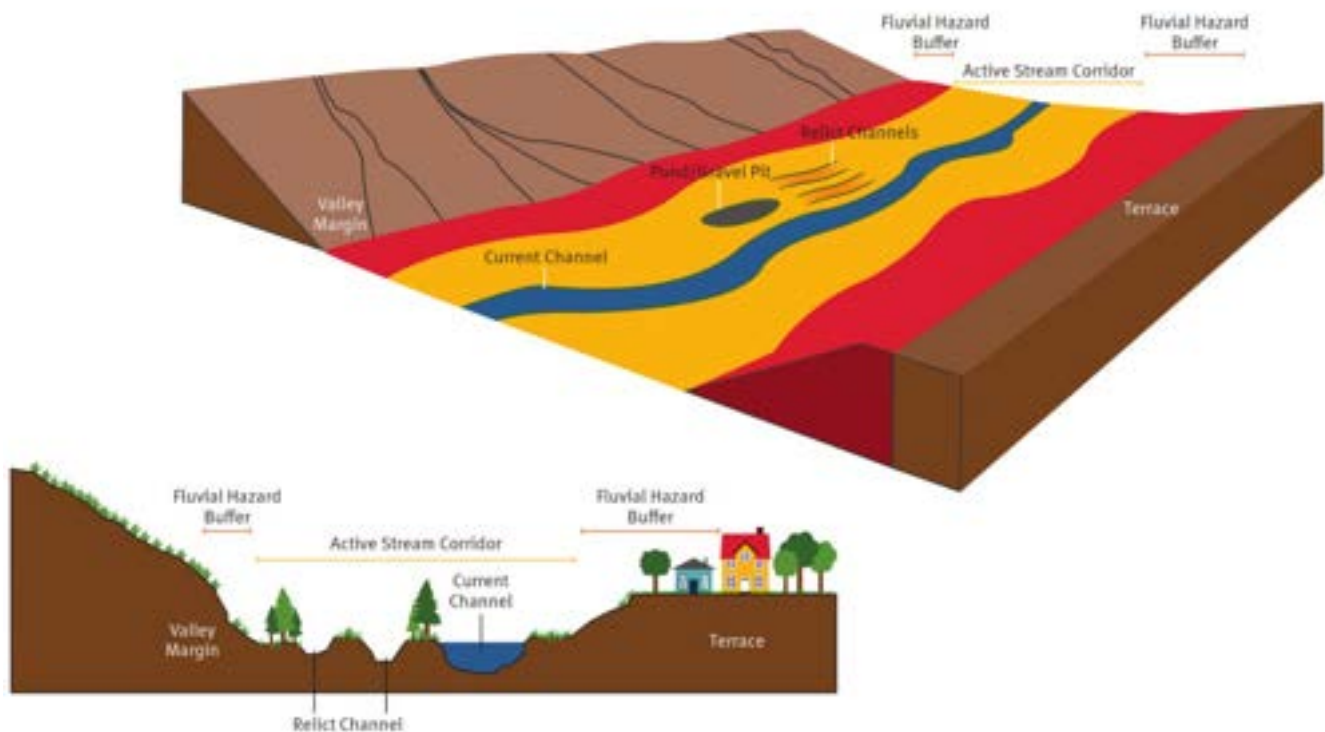
Figure 2-1: The Active Stream Corridor and Fluvial Hazard Buffer are primary components of a Fluvial Hazard Zone map.
Figure from Blazewicz et al. 2020.

Fluvial Hazard Buffer (FHB) The Fluvial Hazard Buffer accounts for erosion-prone land located beyond the Active Stream Corridor, such as hillslopes and terraces, that may be susceptible to slope failure as a result of toe erosion caused by fluvial scour. It is a buffer applied to the outer boundary of the Active Stream Corridor (Figures 2-1 and 2-2).

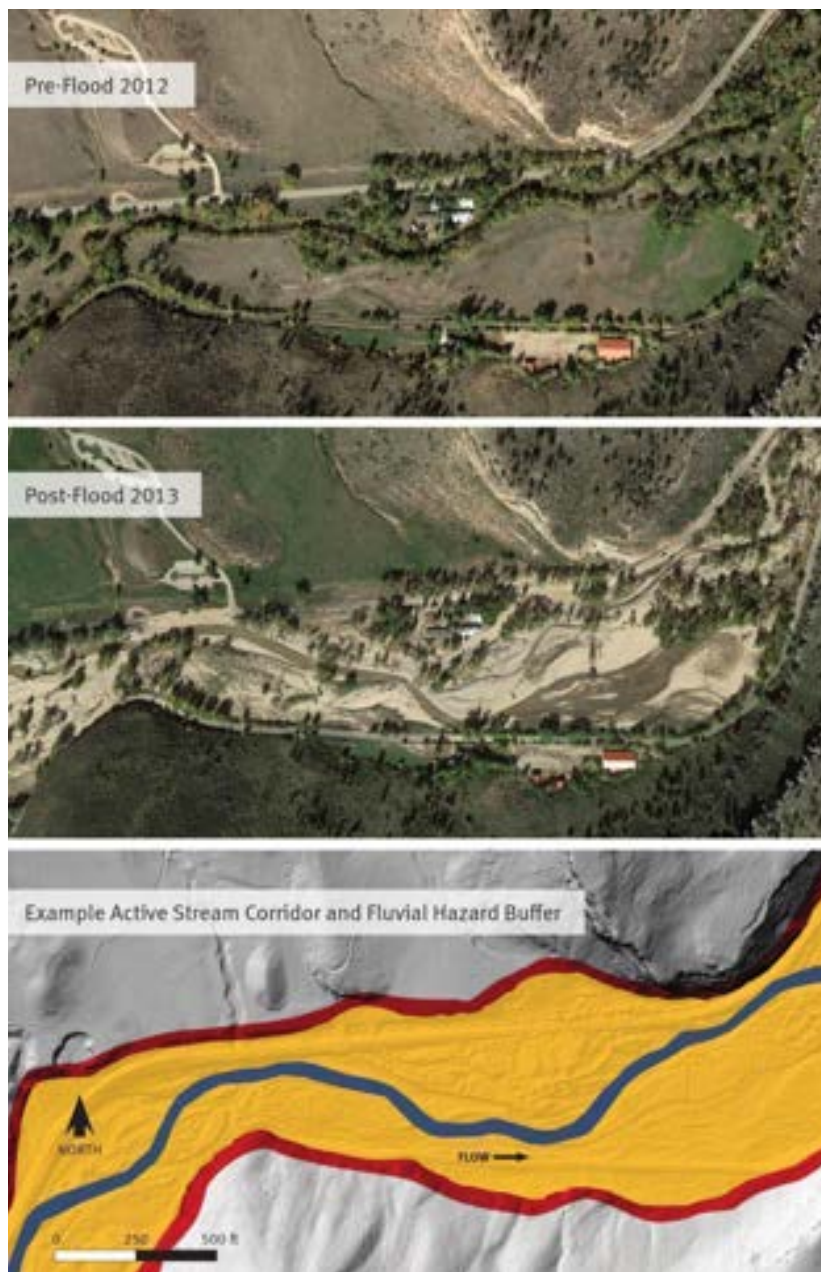
Figure 2-2: Example of Active Stream Corridor as demonstrated before and after the 2013 Front Range Flood (South St. Vrain Creek, Boulder County). Figure from Blazewicz et al. 2020

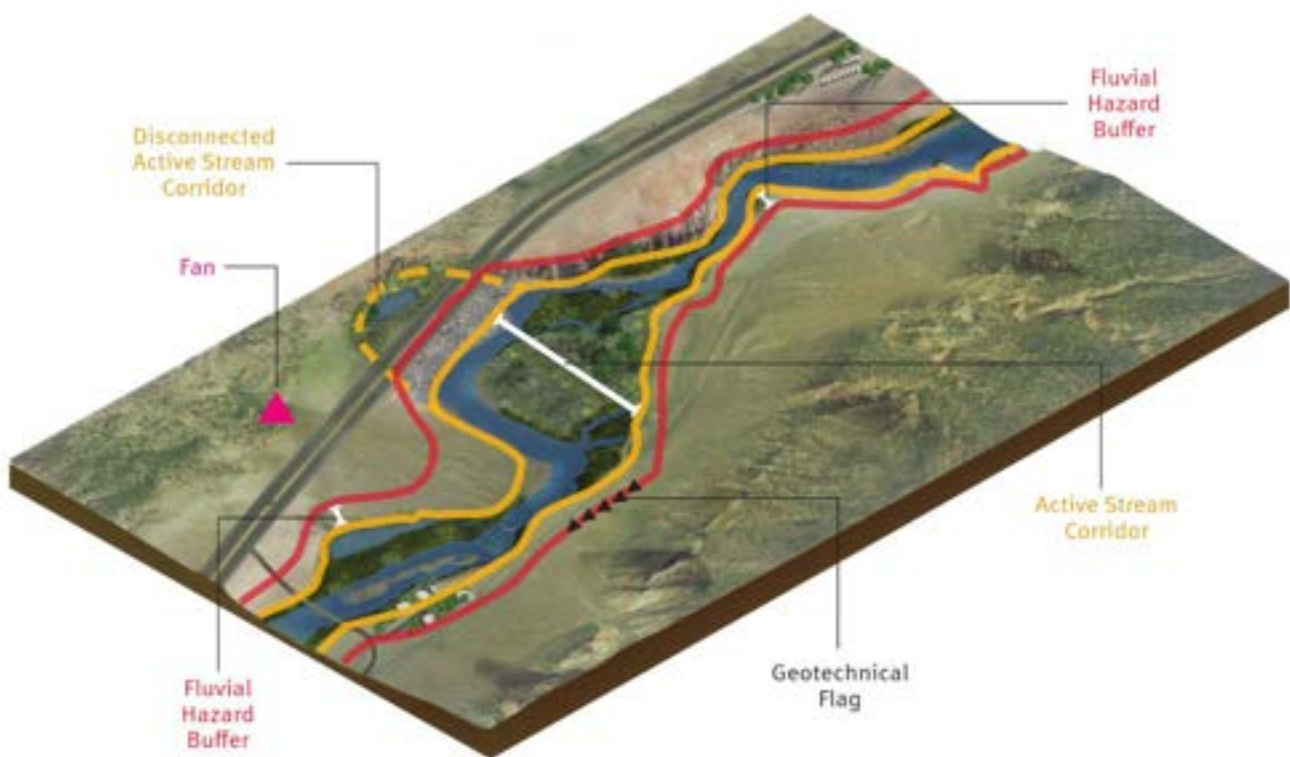
Figure 2-3: Example Fluvial Hazard Zone map containing primary (ASC, FHB) and auxiliary (D-ASC, Fan, and GF) components. Figure adapted from Blazewicz et al. 2020.

Geotechnical Flag (GF) identifies areas where hillslope failures initiated by toe erosion may extend past the Fluvial Hazard Zone delineation due to hillslope steepness, height, and/or material. These should always be examined further through geotechnical analysis before development decisions are made.

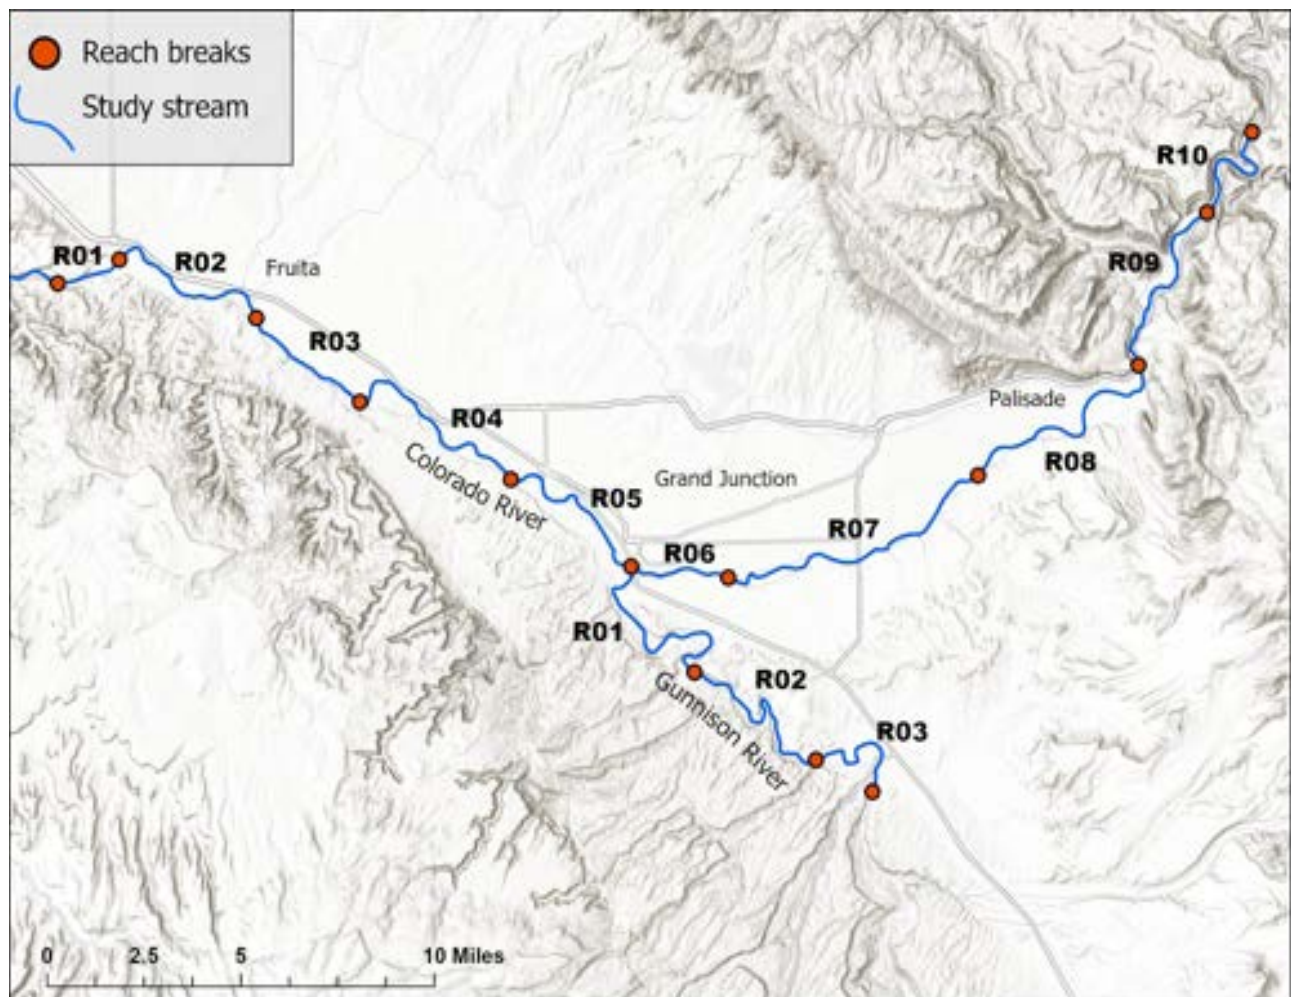
Figure 4-1: Colorado and Gunnison Rivers FHZ study area. Reach IDs are in bold.

The study area for this FHZ mapping project includes 46.4 miles of the Colorado River divided into 10 geomorphically distinct reaches from within De Beque Canyon to the entrance of Ruby-Horsethief Canyon downstream of Fruita. It also includes 15.2 miles of the Gunnison River (three geomorphic reaches) spanning just upstream of Whitewater, CO to the confluence with the Colorado River (Figure 4-1). These reaches serve as basic units of analysis within the FHZ mapping process. Similar valley settings, surficial geology, geomorphic processes, and surrounding land use all inform where reaches begin and end along the river corridor.

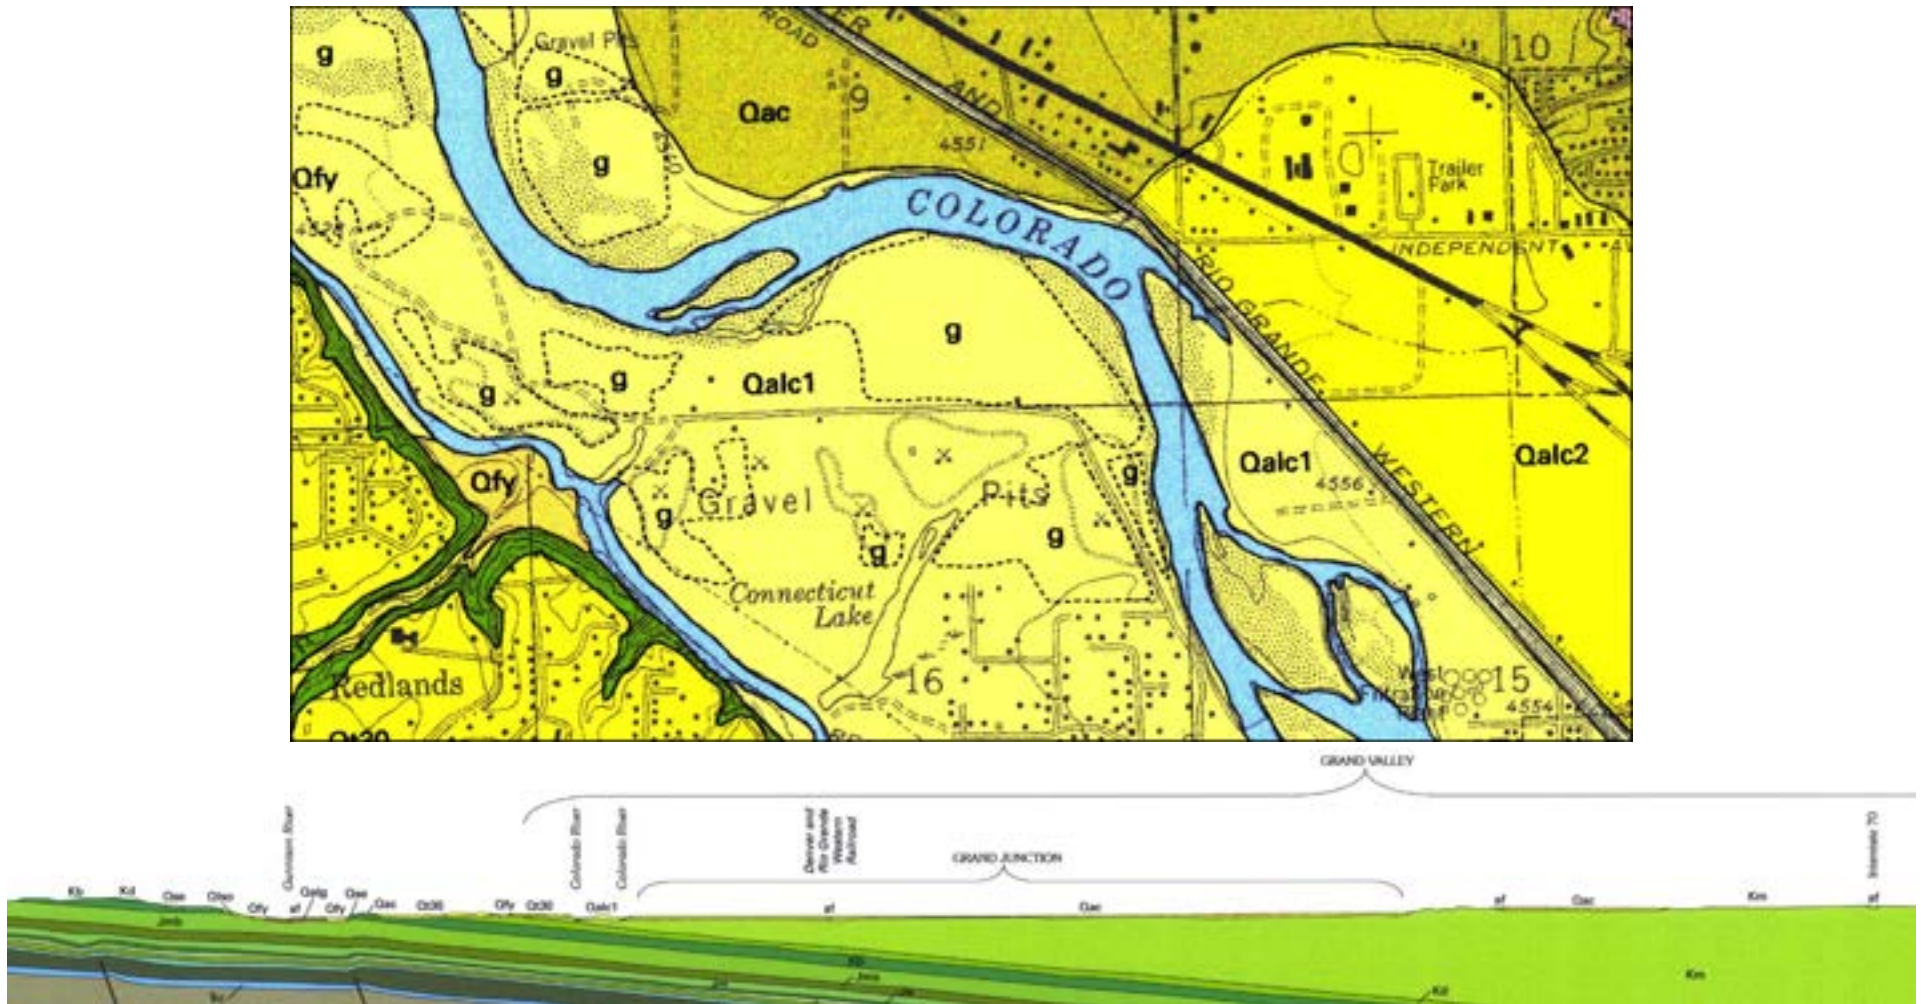
Figure 4-2: (Top) Geologic map of the Colorado River corridor near Grand Junction, CO, 1:24,000 scale (from Scott et al., 2002). This modern mapping identifies the relative ages of the alluvial deposits (Qalc1, Qalc2), fan deposits (Qfy), and Pleistocene alluvial-colluvial terraces (Qac). The green areas on the south valley margin are mapped as Mancos Shale (Km). Gravel ponds (g) are also noted. (Bottom) Geologic cross section of the Grand Valley running roughly south (left) to north (right) and crossing the Gunnison and Colorado Rivers upstream of their confluence (from Scott et al., 2002)

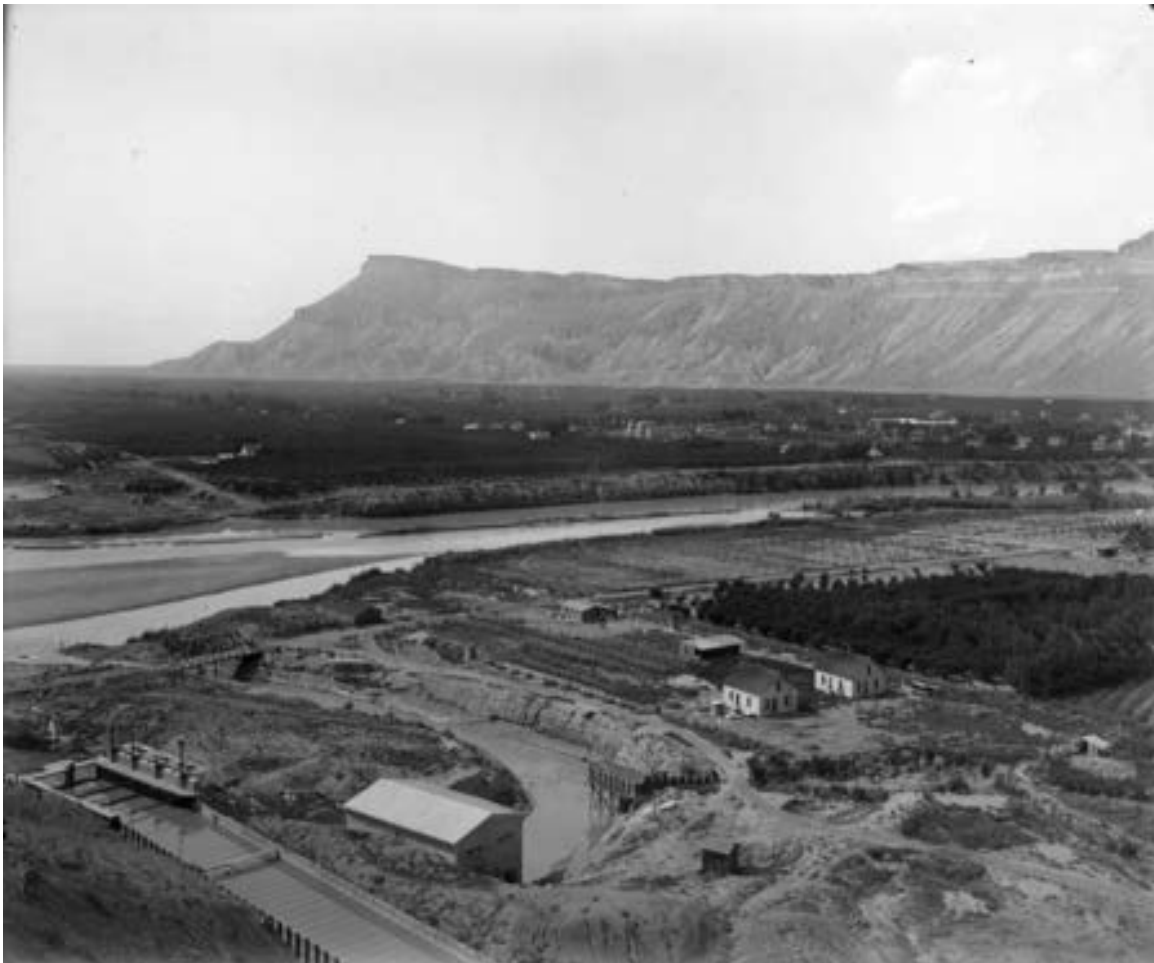
Figure 4-3: Early 20th century (~1912) image of diversion system along the Colorado River near Palisade, CO (Denver Public Library).

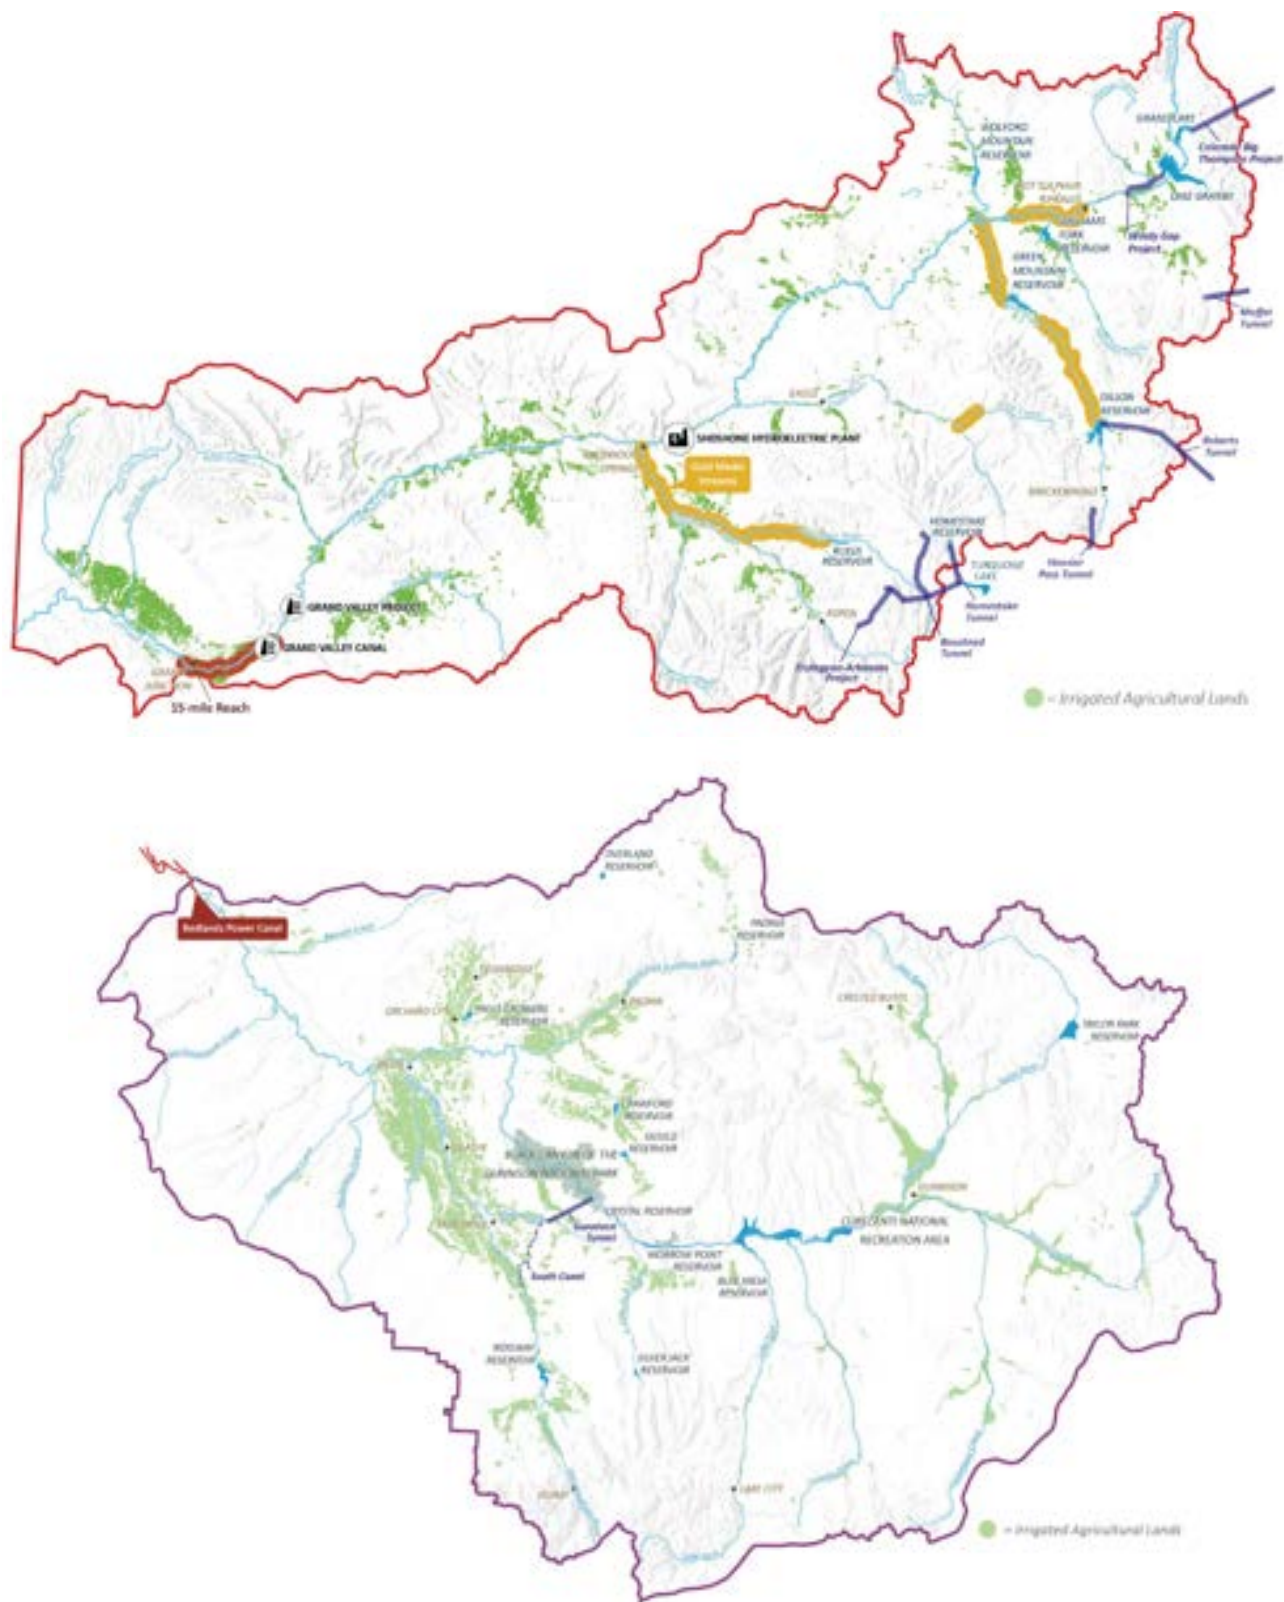
Figure 4-4. Colorado and Gunnison River Basins showing major reservoirs and water diversions (From CWCB 2022).

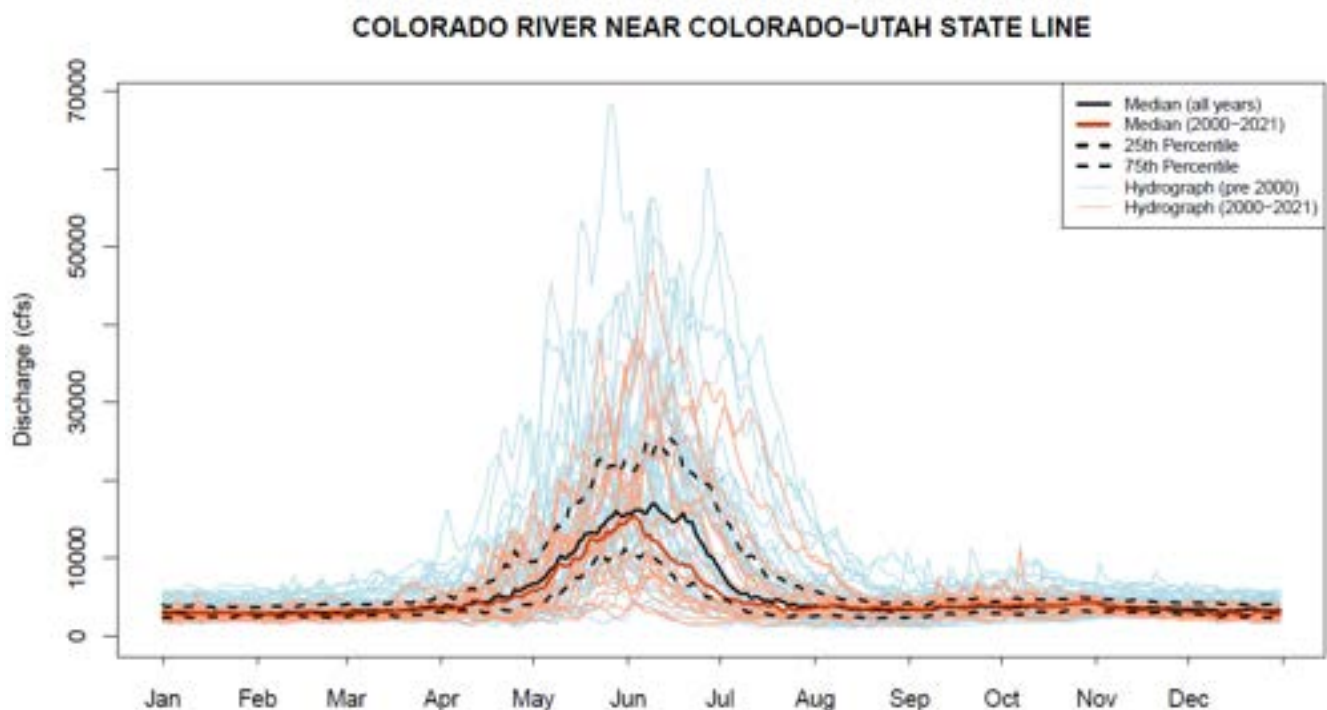
Figure 4-5: Annual hydrographs and median (all years and post 2000) with quartile hydrographs (all years) for flows passing through the USGS gage at the Colorado-Utah State line (Station ID: 09163500).

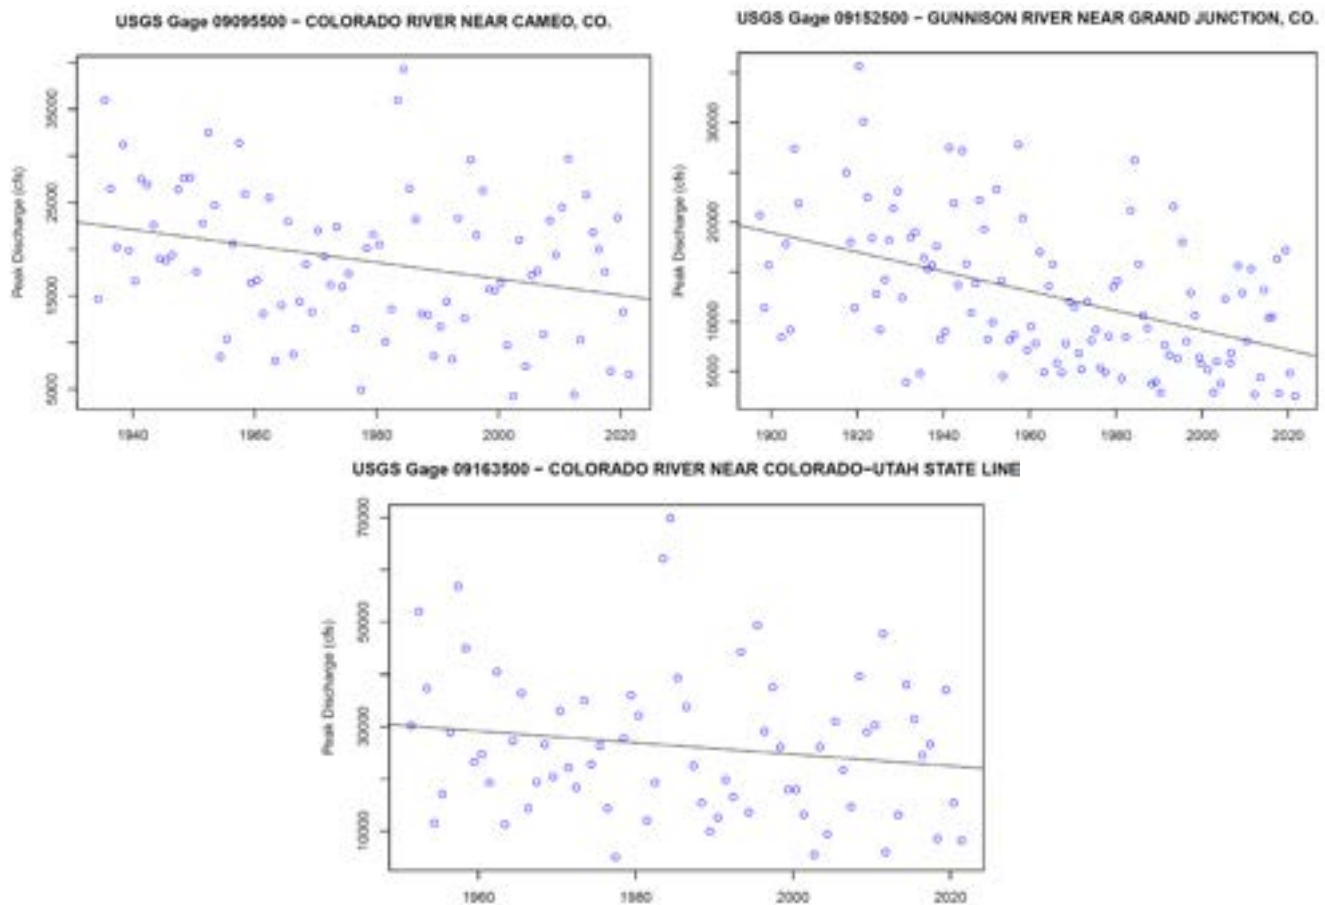
Figure 4-6: Peak streamflow over time for the Colorado (at Cameo in De Beque Canyon and the CO-UT Stateline) and Gunnison Rivers as recorded at USGS stream gages. All three gages show decreasing linear trends of peak discharge over time; however, only the trends at the gages on the Colorado River at Cameo and on the Gunnison River (top two) are statistically significant.

Though peak discharges have been relatively lower over the past 20 years (Figure 4-6), notable peaks in 2011, 2014, and 2019 occurred. Channel migration, new island formation, and bank erosion along the Grand Valley accompanied the large peak flows and are a clear indication of the important connection between hydrology and geomorphic change. Although less common, larger flows and the increased sediment loads they carry and mobilize are ultimately a major influence on river corridor morphology. In comparison, a reduction in large flows may, over time, result in less dynamism, reduced connection with riparian and floodplain areas, and thus the potential encroachment by humans and developments, who may be unaware of the river corridor's historic and potential extent and level of dynamism. Additionally, native and exotic vegetation establish during extended periods of low runoff years, serving to narrow and simplify the geomorphology of the study rivers (Van Steeter and Pitlick, 1998).

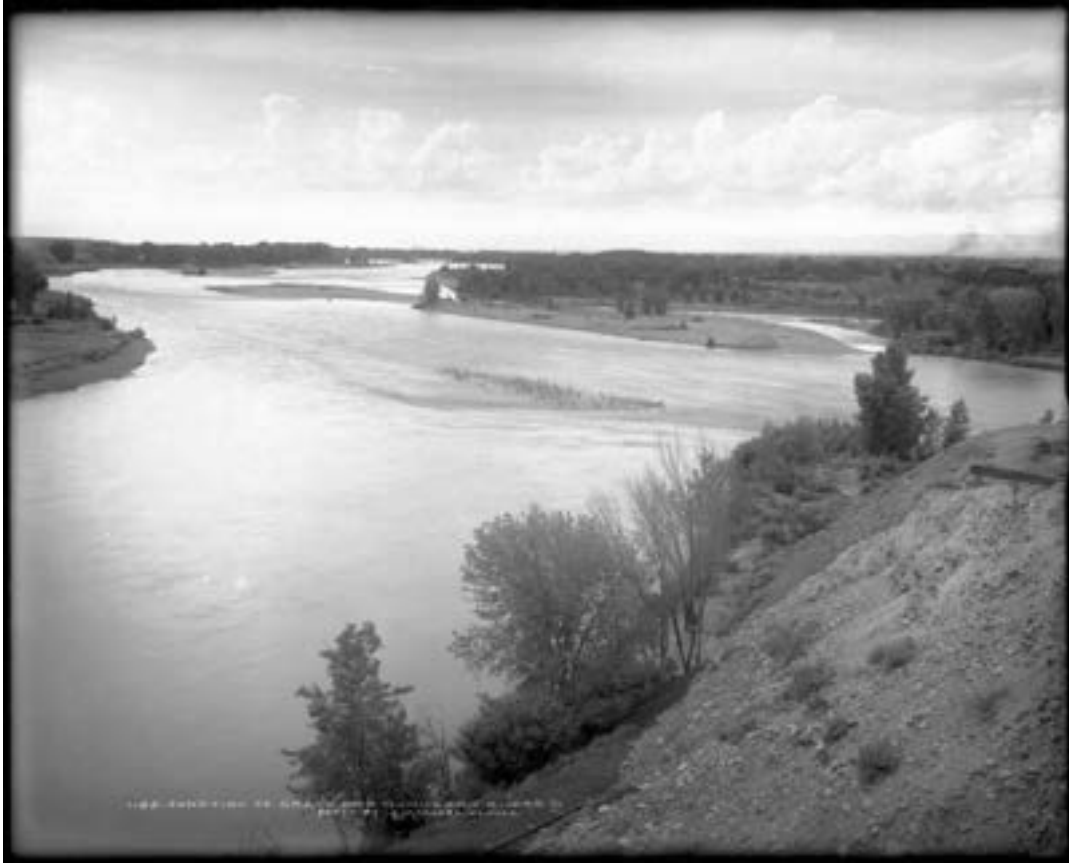
Figure 4-7: Early 20th century (~1907) image of the confluence between the Colorado and Gunnison Rivers looking downstream from the right bank of the Gunnison and the left bank of the Colorado (Denver Public Library).

As the Colorado River travels through the Grand Valley, the river becomes less confined (Figure 4-7). Valley margins along the northern side consist of terraces of colluvium and alluvium of glacial origin as well as more contemporary alluvium. To the south, the river cuts into bluffs of Mancos Shale, where debris flows and hillslope failures are common.

Disconnected Active Stream Corridors are areas in a valley that would historically be in the Active Stream Corridor but are not currently experiencing fluvial processes due to disconnecting infrastructure such as levees or major highways. Within the Grand Valley, as highlighted previously, two Disconnected Active Stream Corridor were identified: (1) in and around Las Colonias and (2) near Fruita, where I-70 cuts off the historic Active Stream Corridor (Figure 4-7).

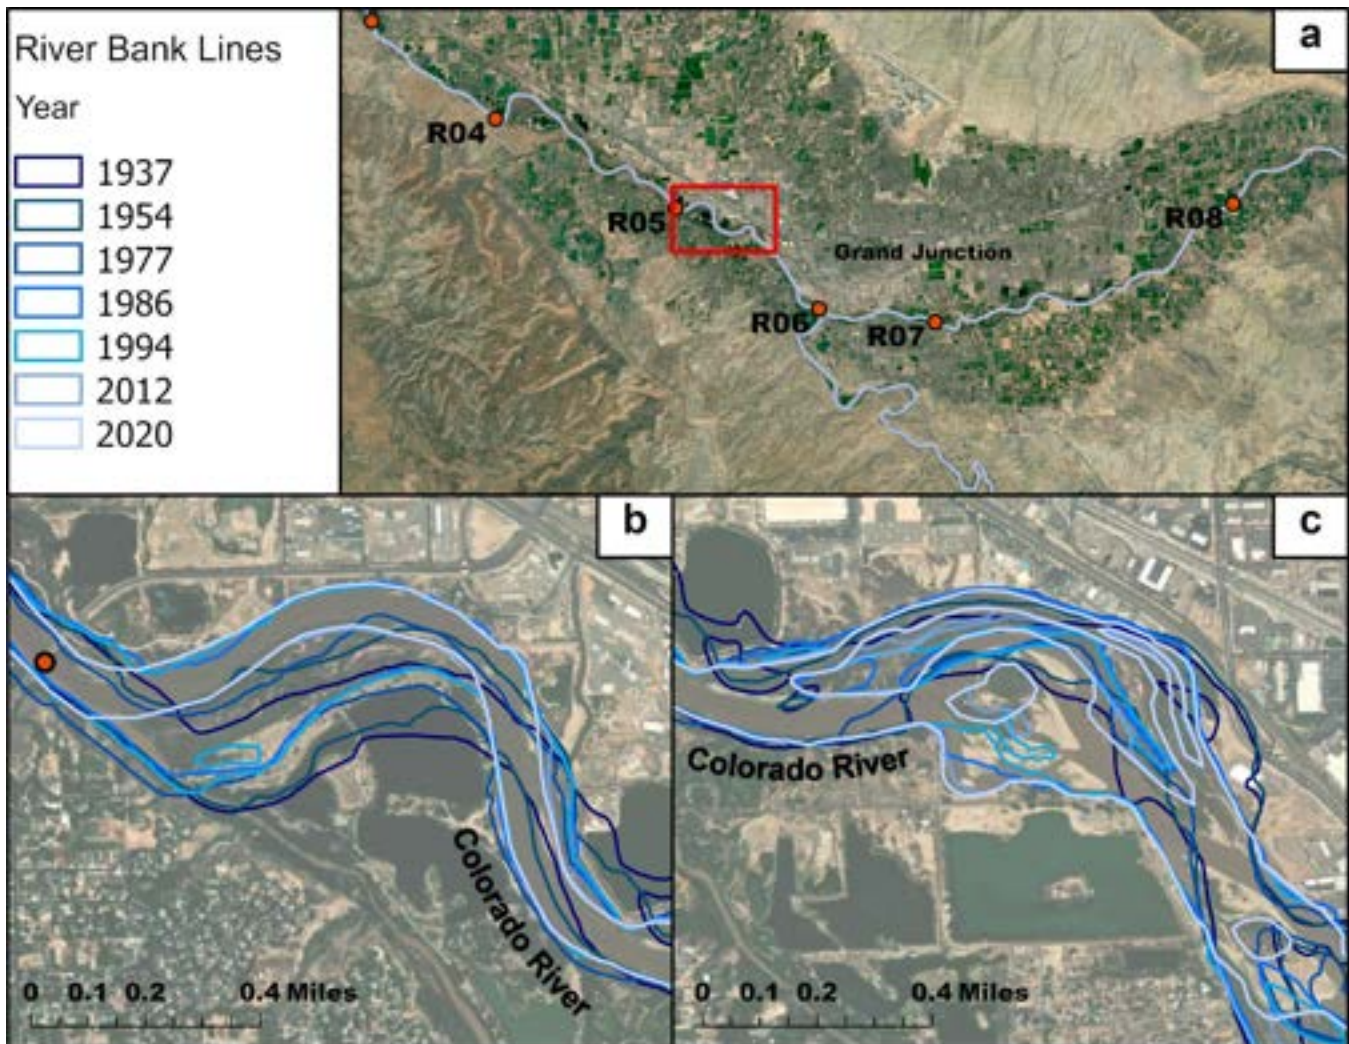
Figure 4-8: Examples of channel migration near Redlands Parkway (Colorado Reach R05): a) study extent, b) all delineated banklines near Redlands Parkway, c) all delineated banklines just upstream of Redlands Parkway.

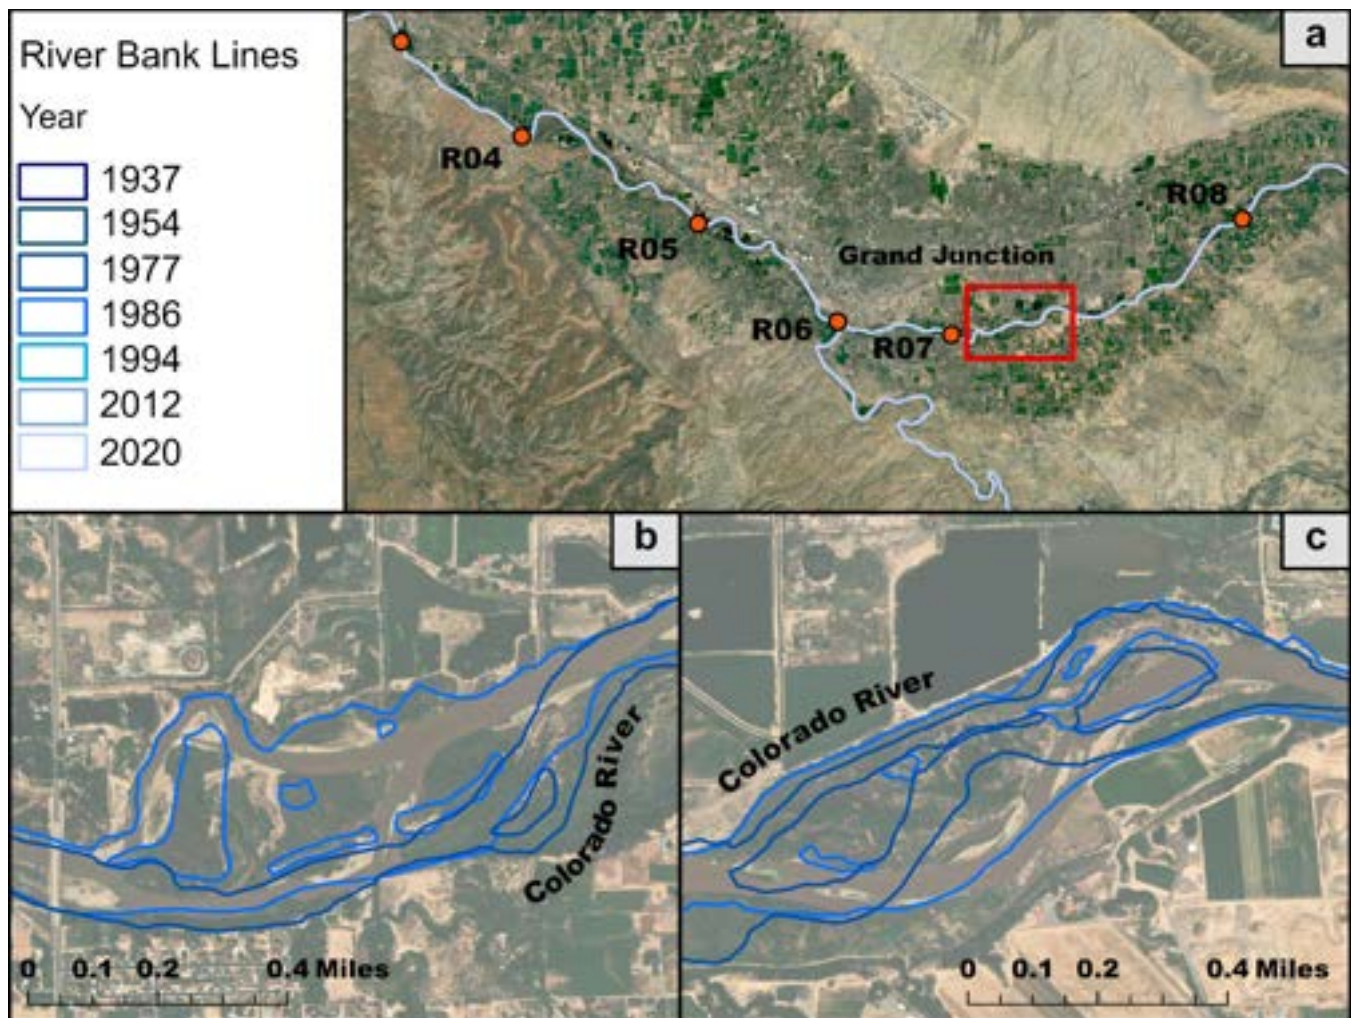
Figure 4-9: Examples of channel changes after flood events, just upstream of 29 Road (Colorado Reach R07): a) study extent, b) delineated banklines (1977, 1986) near 29 Road with examples of island and side channel creation, c) delineated banklines (1977, 1986) upstream of 29 Road with examples of meander erosion and channel widening.

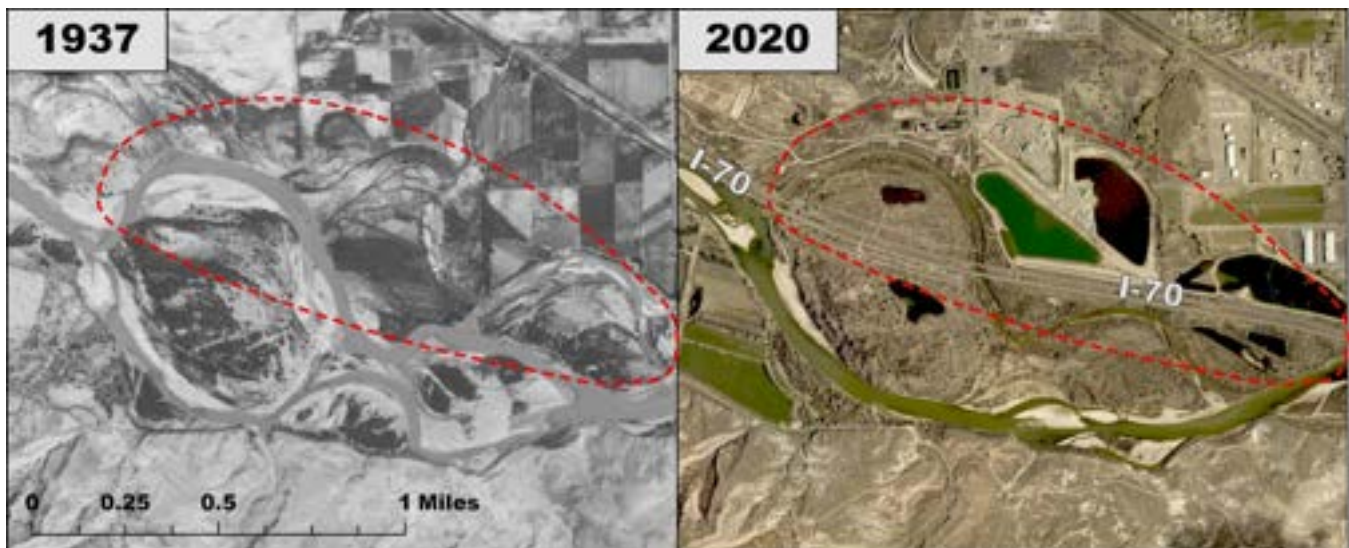
Figure 4-10: Before (1937) and after (2020) imagery documenting the effect I-70 played on corridor disconnection.

Further downstream on the Colorado River, various encroachments of roads and the railway, as well as channel crossings, exist, constricting the Active Stream Corridor and posing potential hazard during disturbances. Most notably is the corridor cutoff enacted by I-70 just upstream of the City of Fruita near 16 Rd (Figure 4-10). The highway separates the historically active corridor (as seen in 1937 imagery) from where the current river travels, and even travels over a slowly diminishing active side channel within the area. Driving the Colorado River into largely one channel, as well as reducing and disconnecting floodplain and riparian areas, has likely resulted in greater sediment loads being transported downstream rather than depositing and driving geomorphic complexity. Riparian habitat has also decreased, and flood conveyance and erosive energy has increased, leading to greater potential downstream risks.

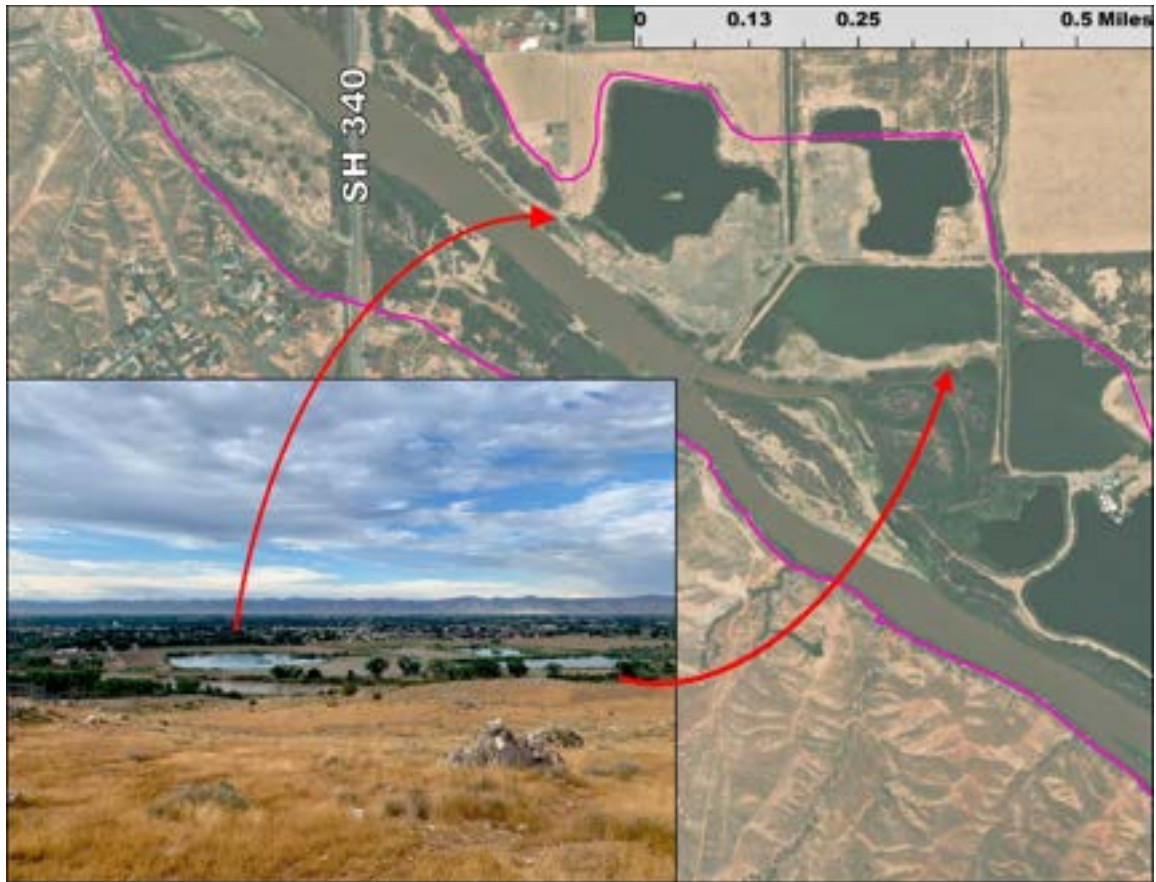
Figure 4-11: Examples of the numerous gravel ponds that exist within the Active Stream Corridor (pink lines). This example is near Fruita and 16 Rd just upstream of CO State Highway 340.

During floods, gravel ponds can play an influential role in transferring or shifting hazards. The capture of reservoirs, ponds, and gravel pits of a migrating river can result in erosion and deposition in areas that do not typically experience fluvial processes. For this reason, such areas are typically included in the Active Stream Corridor delineation. Within our study region, there is a large presence of gravel mining and gravel ponds. Because of the potential hazard associated with pit capture during disturbances, the Active Stream Corridor has been extended to include these gravel ponds (Figure 4-11).

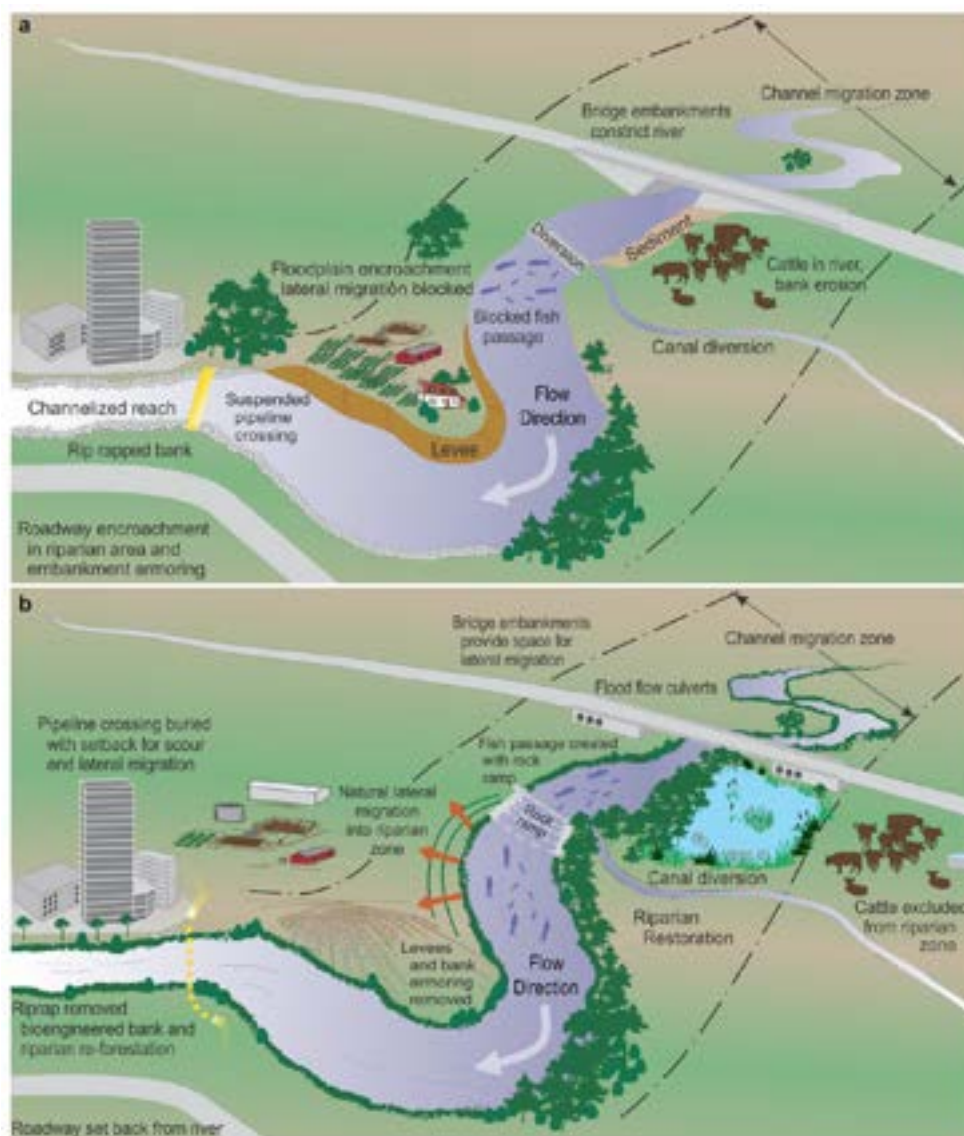
Figure 6-1. Examples of less (a) and more (b) river compatible infrastructure design. From Sholtes et al. (2018).

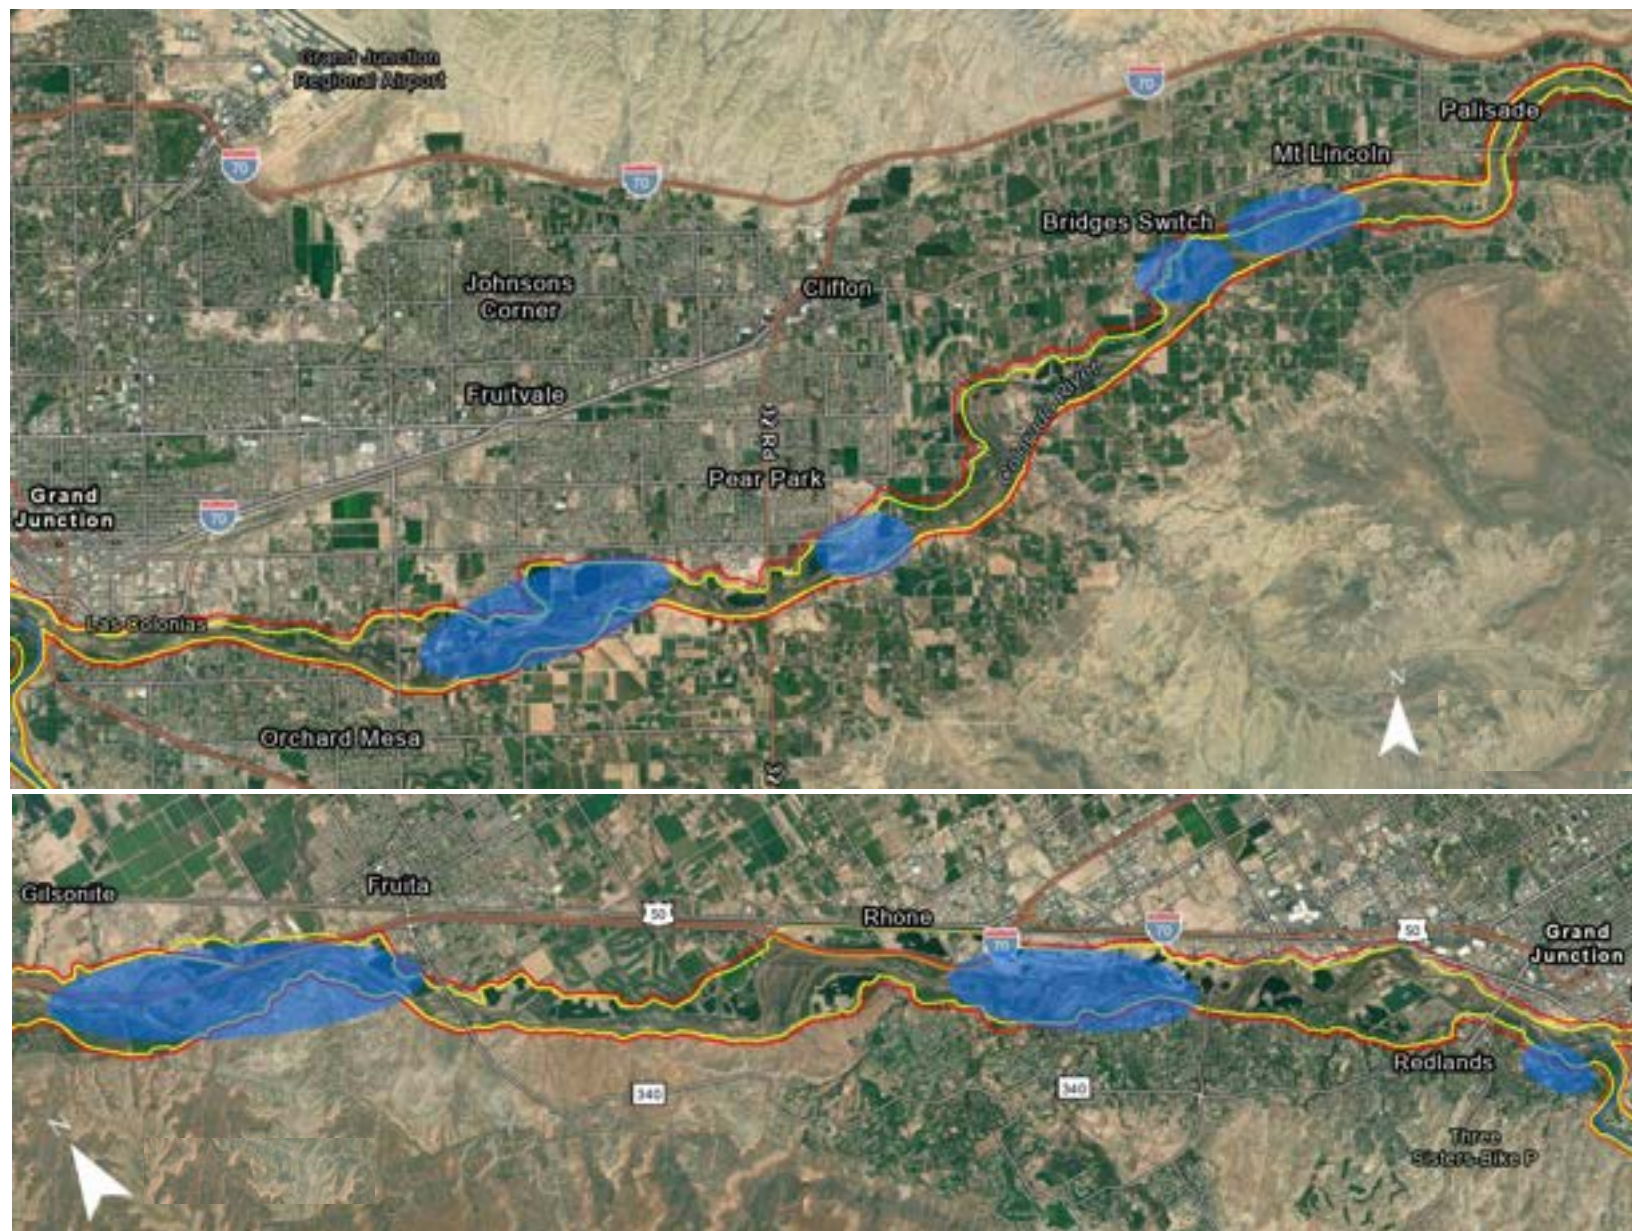
Figure 6-2. Areas (blue) where channel migration may be supported within the Grand Valley.
