Grand Valley River Corridor Initiative

Fluvial Hazard Zone Mapping Addendum for the Colorado River and Gunnison River in the Grand Valley, Mesa County, Colorado

March 2023

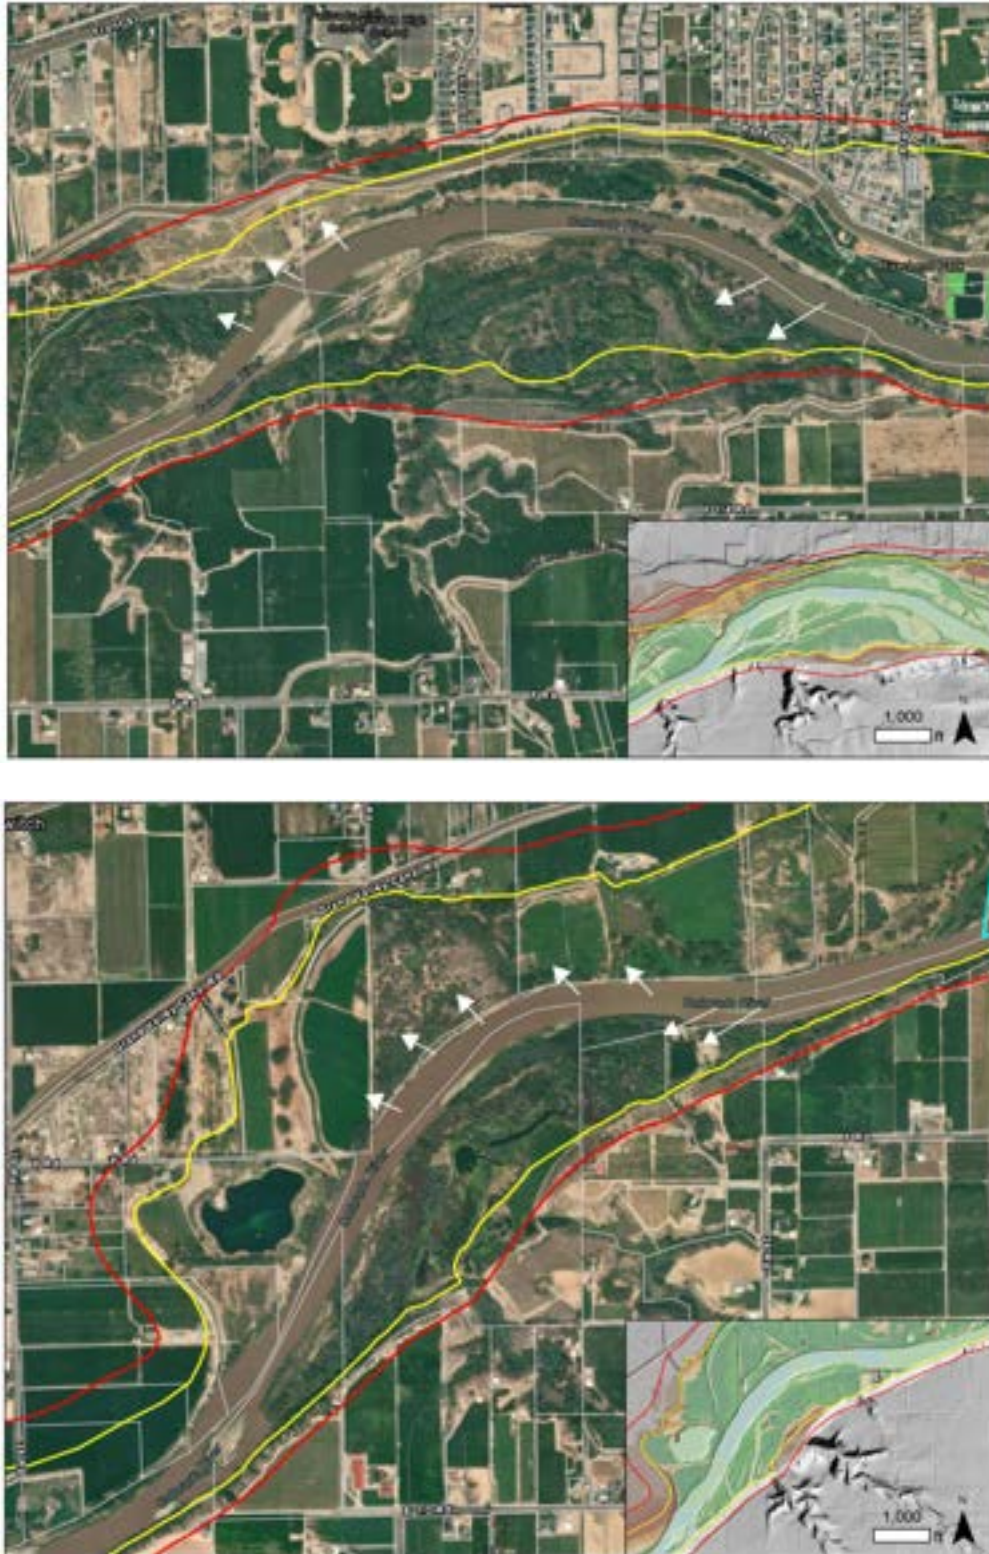
Figure 6-3. Potential channel migration zones within the Grand Valley's Active Stream Corridor. White arrows indicate likely direction of channel migration. (Top) Just downstream of Riverbend Park in Palisade. (Bottom) Unincorporated Mesa County at 35 ½ Road.

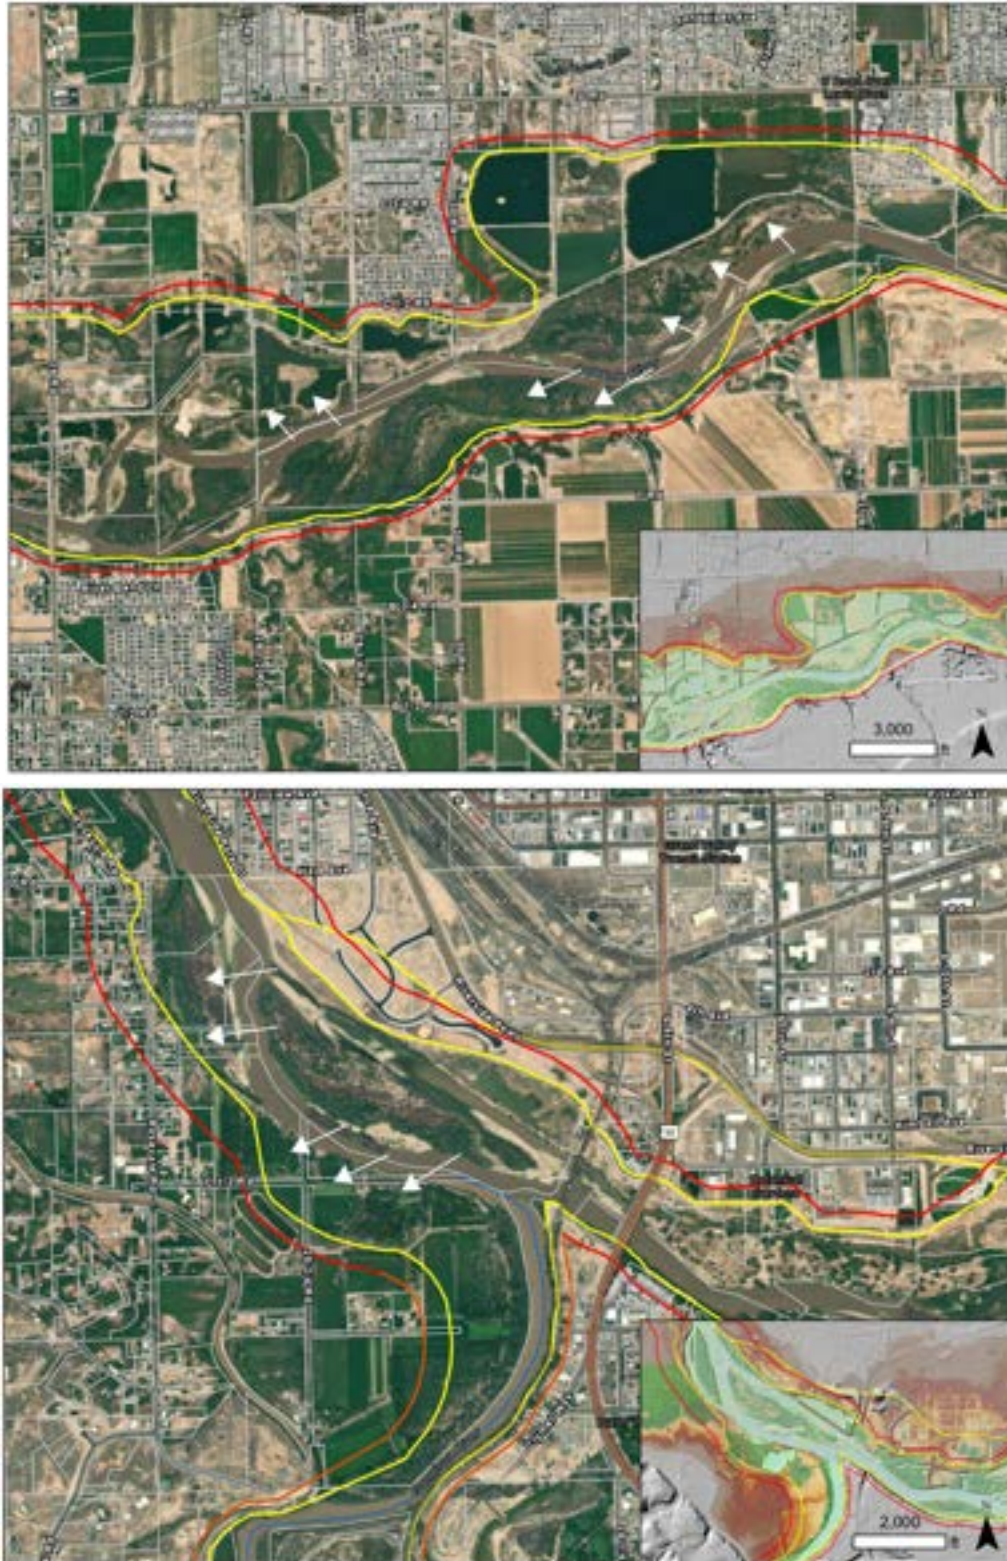
Figure 6-4. Potential channel migration zones within the Grand Valley's Active Stream Corridor. White arrows indicate likely direction of channel migration. (Top) Unincorporated Mesa County at 31 Road to 29 ½ Road. (Bottom) Just downstream of confluence with the Gunnison along left bank.

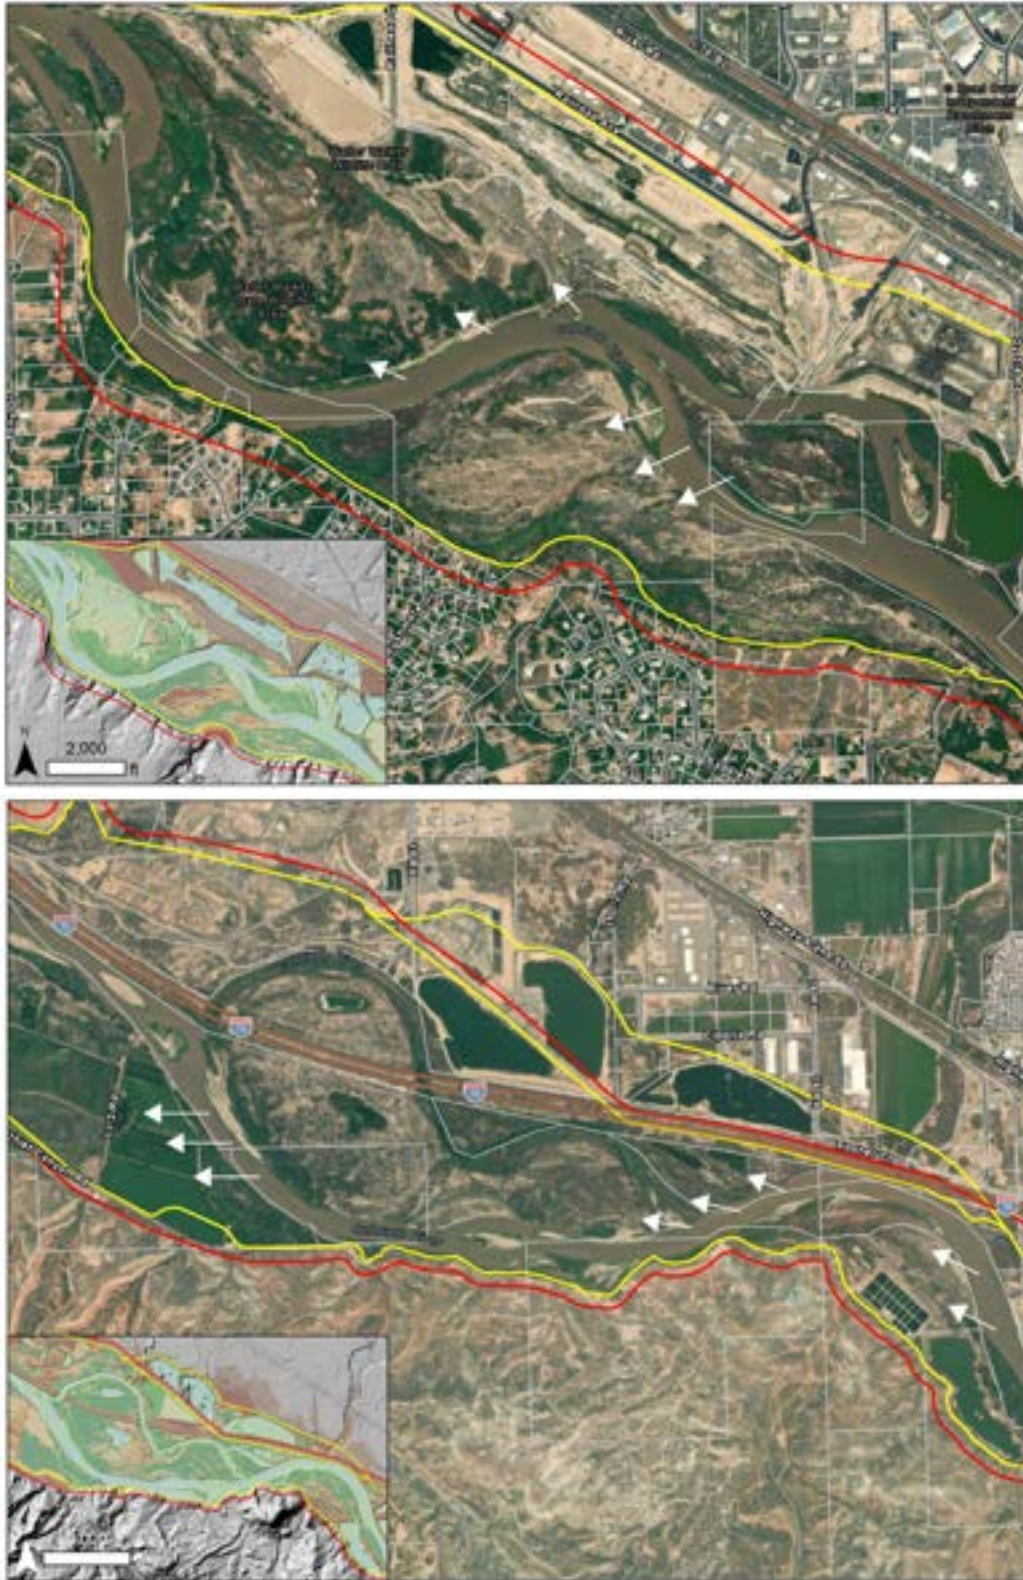
Figure 6-5. Potential channel migration zones within the Grand Valley's Active Stream Corridor. White arrows indicate likely direction of channel migration. (Top) At Walter Walker State Wildlife Area. (Bottom) Unincorporated Mesa County in the vicinity of 15 Road to 16 Road.

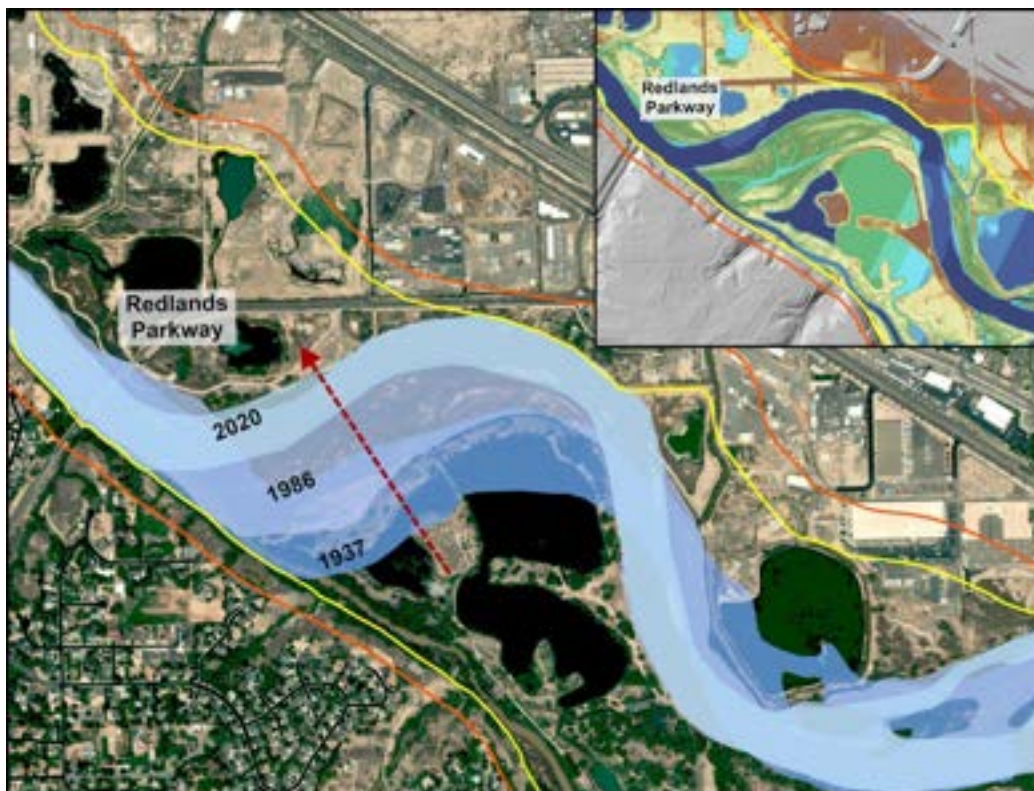
Figure 6-6. Progressive channel migration towards Redlands Parkway.

In locations where channel migration is approaching or adjacent to infrastructure there are typically two options: (1) move or modify the infrastructure and (2) mitigate the migration. Moving or modifying infrastructure within the ASC may involve widening abutments or embankments for bridges, burying pipelines with a wide enough setback to avoid channel migration, or simply removing infrastructure (Figure 6-1). Mitigating the migration may include bank armoring and/or river training structures. Such interventions should be designed to address local and downstream migration. They should also consider local and downstream impacts of arresting migration. Specific examples of where options (1) or (2) may be more or less feasible are explored in the subsequent sections below.

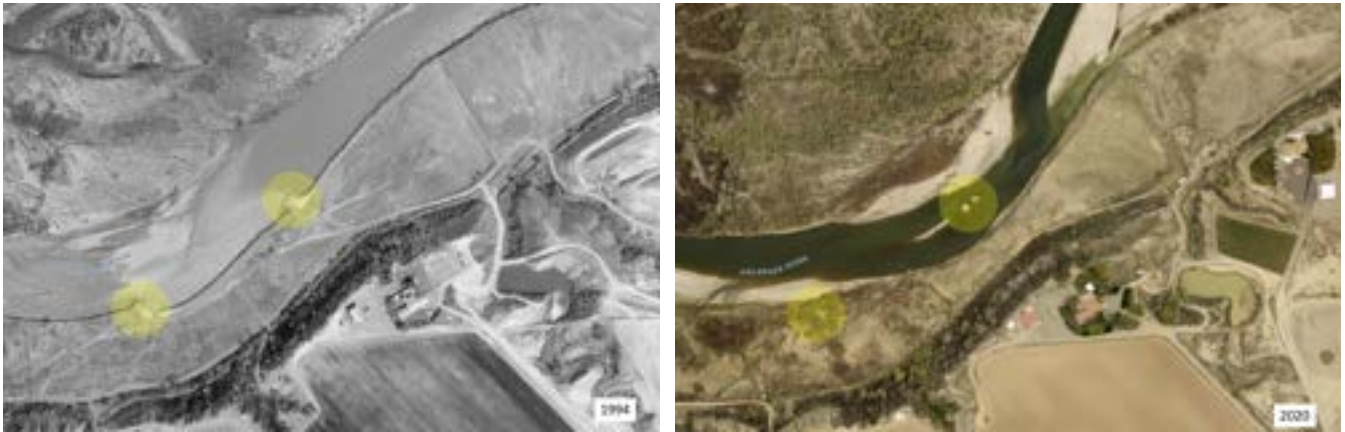
Figure 6-7. Bank armoring structures flanked by a migrating Colorado River. Located at approximately 30 ½ Road.

There are many examples of failed or failing riprap located along the Colorado River in the Grand Valley, as well as riprap that the channel has migrated beyond leaving the material in the middle of the channel. Most bank armoring projects have a limited lifespan and require regular maintenance to ensure they continue to meet project needs. As such, designing and installing riprap or other bank armoring becomes a long-term financial and maintenance commitment to “holding the line” with a particular streambank. Figures 6-7 and 6-8 show examples of bank armoring in the Grand Valley.

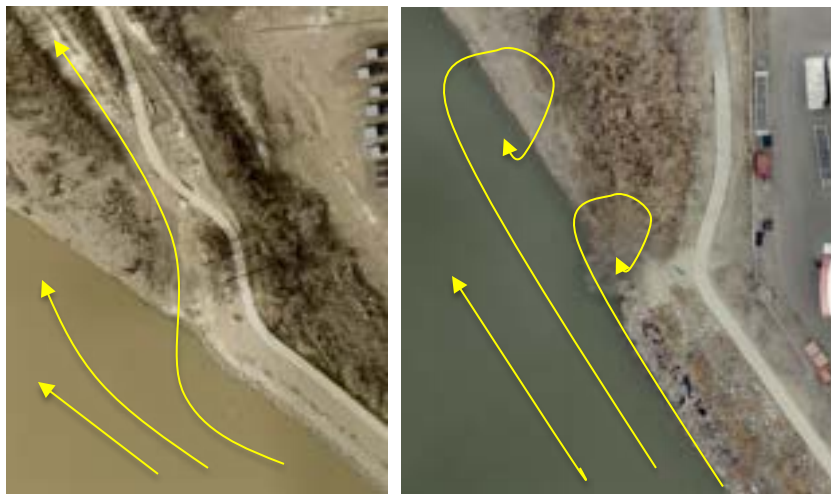
Figure 6-8. (Left) Bank armoring that transitions to a side channel where flood energy is naturally dissipated. (Right) Abrupt end of bank armoring with bank erosion occurring downstream along unarmored bank. Yellow lines indicate hypothetical flow paths.

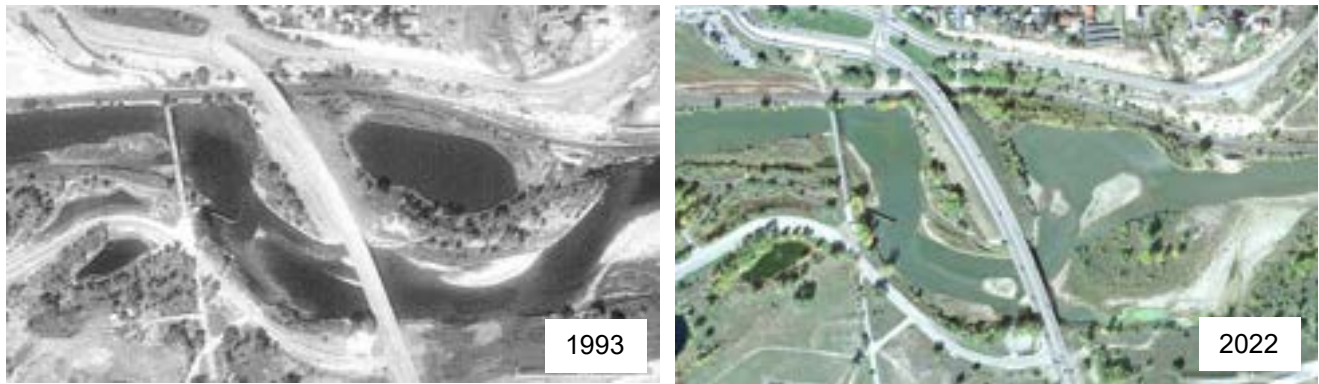
Figure 6-9. Gravel pond upstream of bridge at Rifle, Colorado captured by the Colorado River.

Gravel ponds can deter channel migration where bank armoring and berming have gone in around them. During flood events, these berms may be breached, thus being captured by the river. Where several gravel ponds exist in line along a river corridor, river channel avulsion may occur in which the channel finds an alternative path through the ponds. Examples of gravel pond capture and avulsion by rivers exist upstream on the Colorado River at Rifle (Figure 6-9) and in the Grand Valley (Figure 6-10).

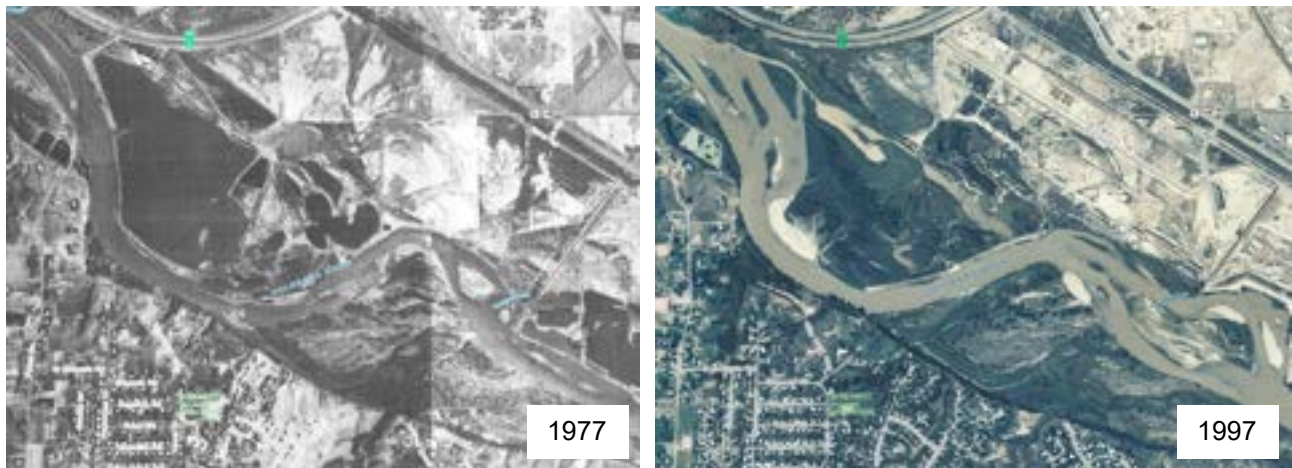
Figure 6-10. Gravel pond located at the (now) Walter Walker State Wildlife Area captured by the Colorado River.

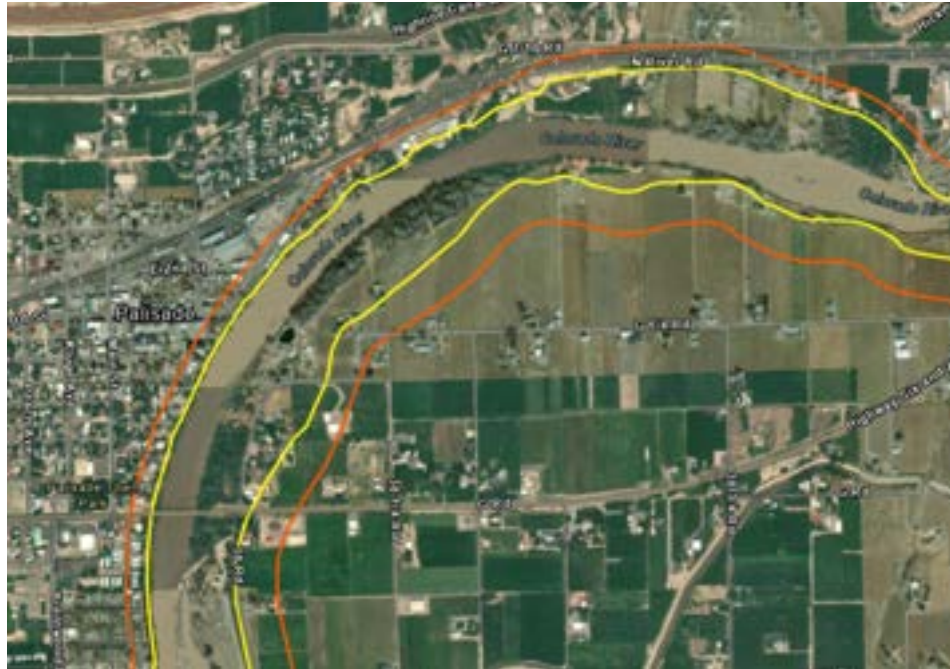
Figure 6-11. The Fluvial Hazard Zone boundaries (ASC and FHB) for the Colorado River at Palisade, CO.

The Town of Palisade is located on the outer bend of the Colorado River as it flows out of De Beque Canyon (Figure 6-11). Outer bends of rivers are susceptible to outward channel migration and bank erosion. However, since the earliest aerial imagery taken over 85 years ago, this bank has only moved marginally. That is likely because Palisade is located on a 30- to 40-foot-tall terrace comprised of sand to boulder sized glacial outwash material. Though unconsolidated, this material, along with riparian vegetation, has demonstrated some level of resistance to erosion. Nevertheless, development and utilities located immediately adjacent to the bank and river are still susceptible to fluvial geomorphic hazards from gradual bank erosion and bank failure.

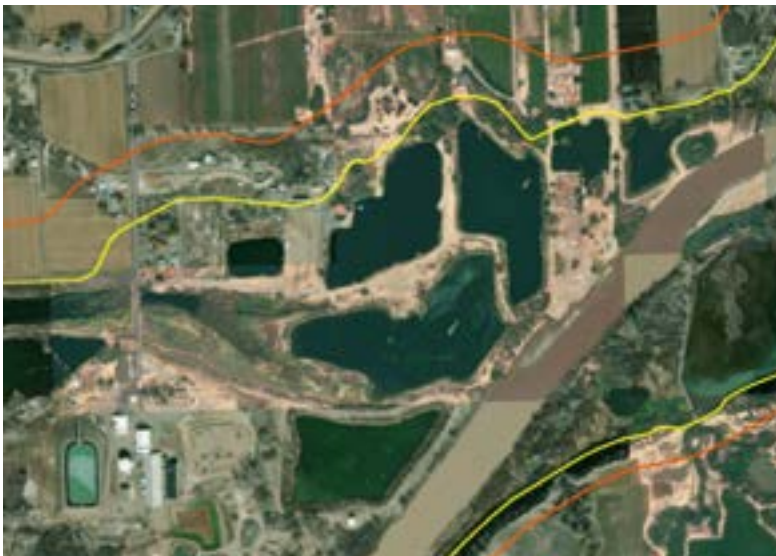
Figure 6-12. Gravel ponds located within the Clifton area constrain flood flows and channel migration.

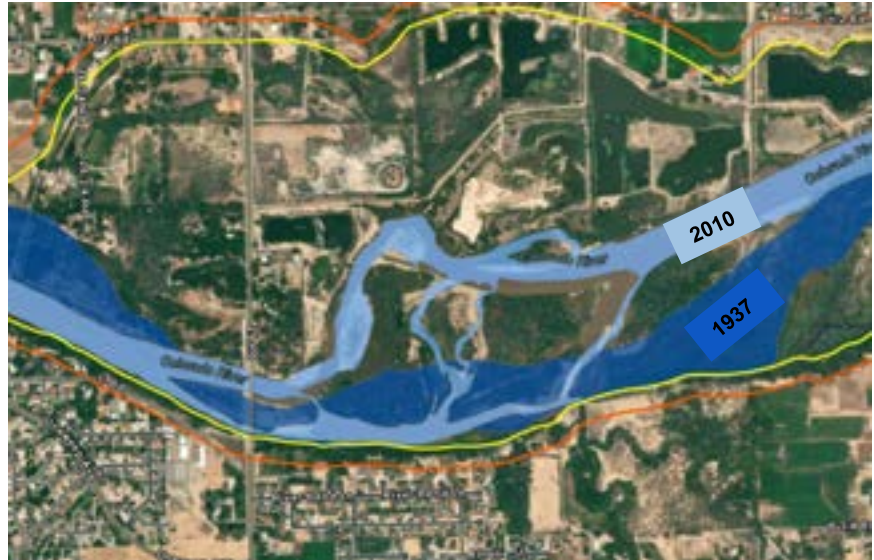
Figure 6-13. Channel migration on the Colorado River towards 29 Road.

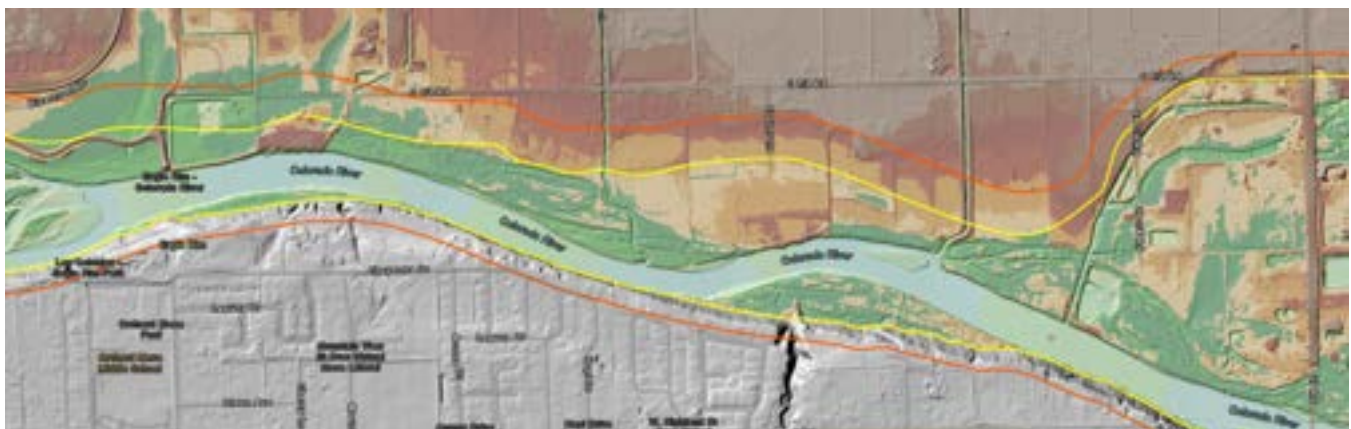
Figure 6-14. Colorado River upstream of Las Colonias in Grand Junction.

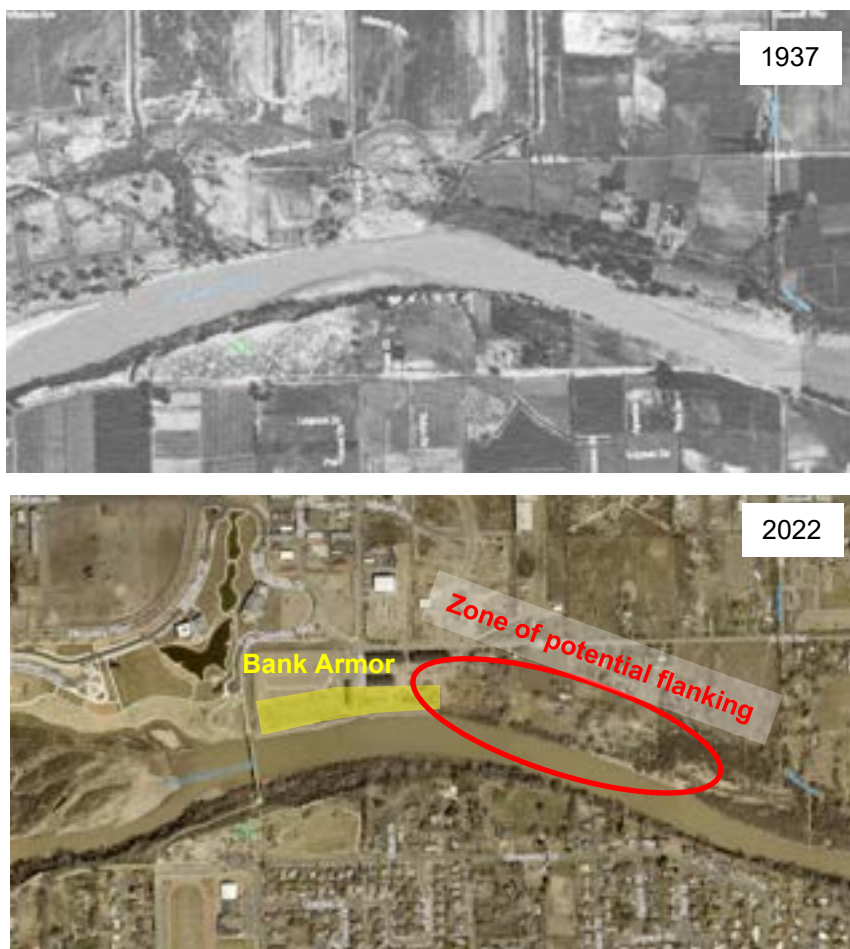
Figure 6-15. Bank armoring east of Las Colonias that ends at apex of outer meander bend may be subject to flanking by channel migration.

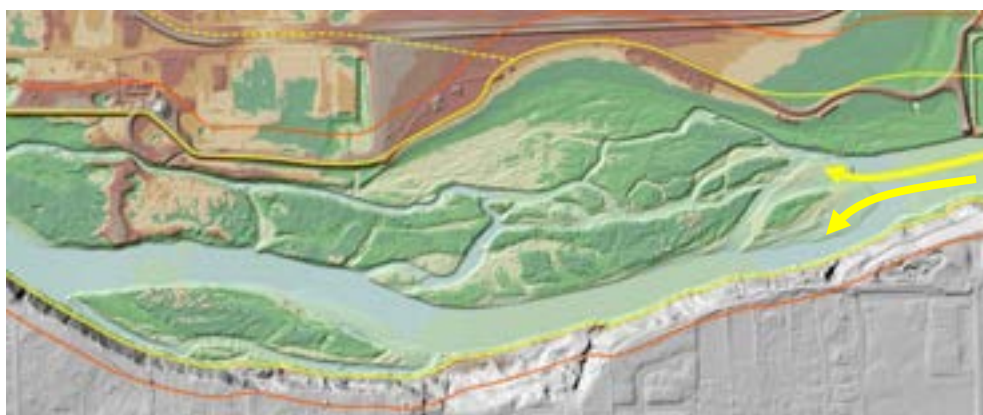
Figure 6-16. Channel expansion and deposition at inlet of the River Park at Las Colonias.

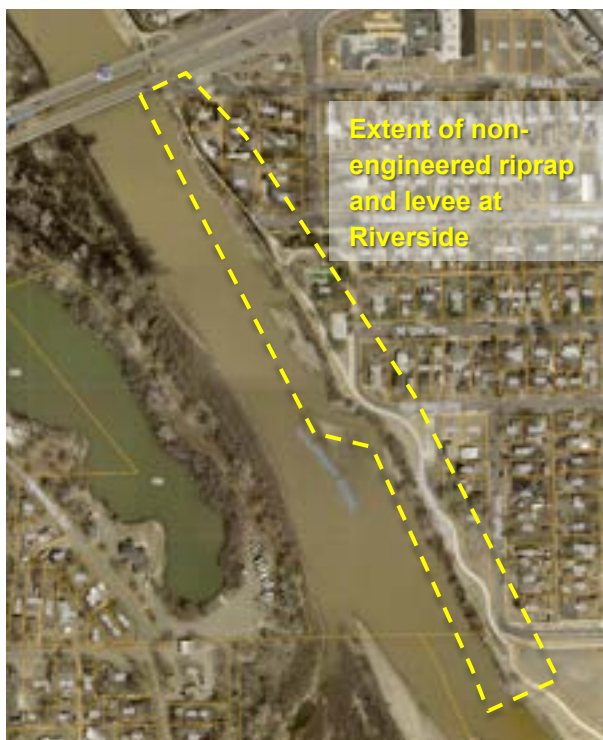
Figure 6-17. Non-engineered bank armoring and levee at Riverside Community.

Recent riverfront re-development at Las Colonias and west at Dos Rios has involved bank armoring and FEMA-certified levee projects. The Riverside Community currently resides behind a non-engineered levee that was hastily constructed in the 1980s in response to large snowmelt runoff years (Trent Prall, Public Works Director, City of Grand Junction, personal communication). The banks of the river here are haphazardly armored with concrete debris and are steep (Figure 6-17). Currently, the Riverside Community has no designed or safe access to the river. The access and lack of flood protection represents an equity issue for the Riverside Community.

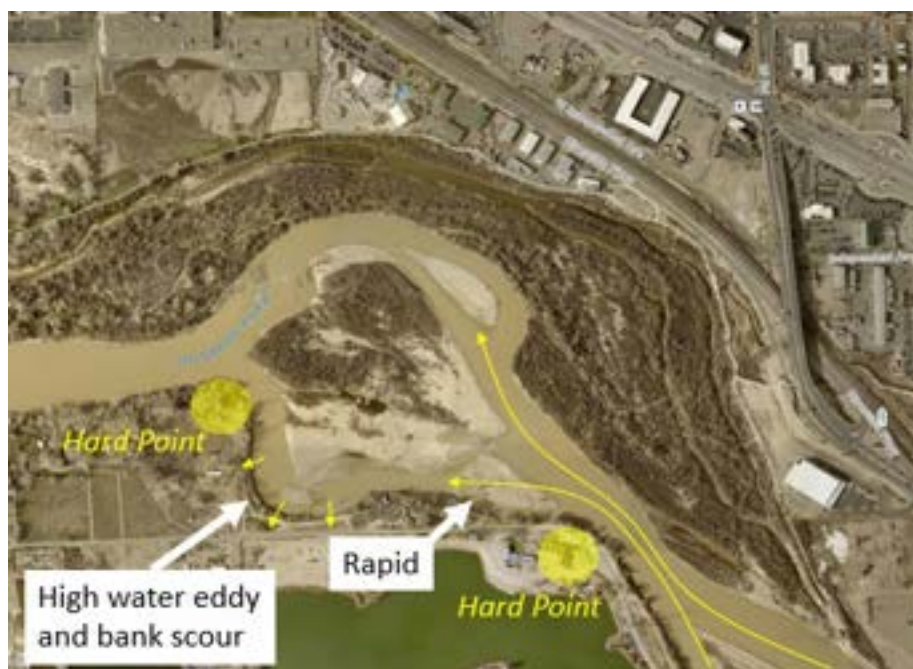
Figure 6-18. Arrested down valley channel migration and artificially forces southward migration at Dike Road near Connected Lakes State Park.

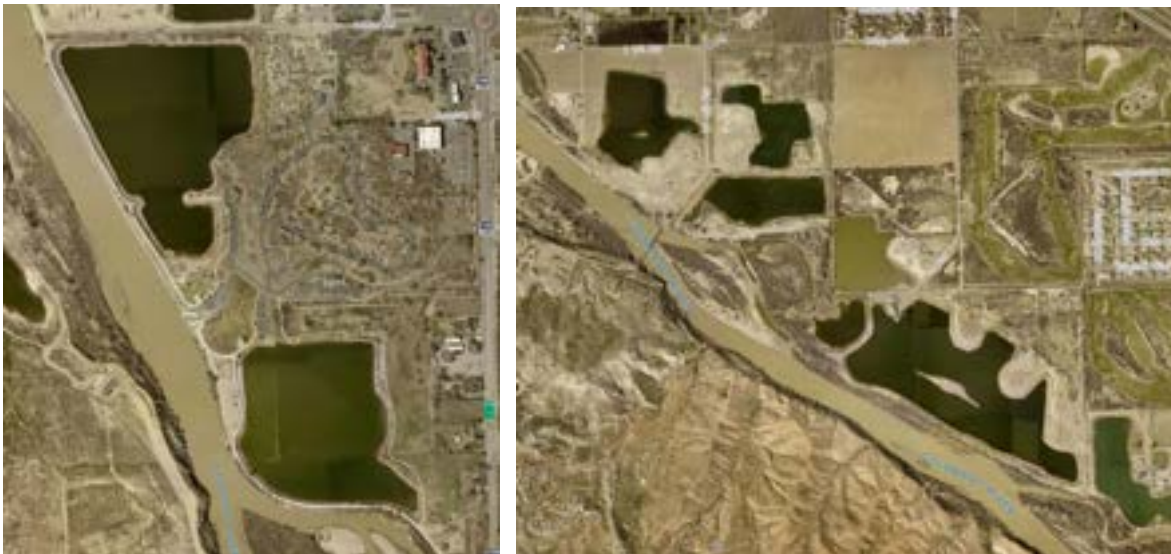
Figure 6-19. Examples of gravel ponds constricting the floodplain of the Colorado River in the Fruita area.

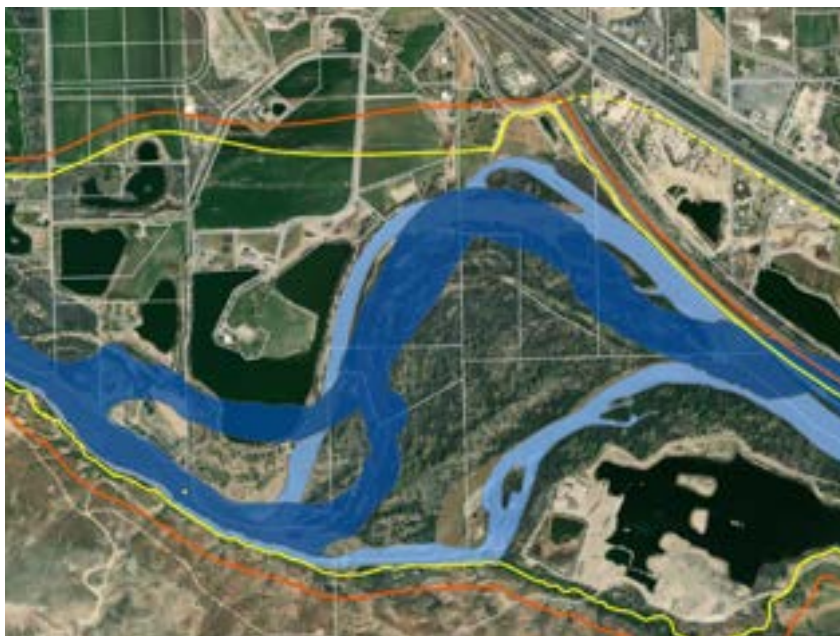
A subdivision was platted and developed within the migratory pathway of the Colorado River in unincorporated Mesa County from approximately 20 Road to 19 Road. These homes are located within the 100-year floodplain as well as the ASC. The existence of these privately owned parcels likely precludes any restoration of down-valley migration or floodplain habitat (Figure 6-20).

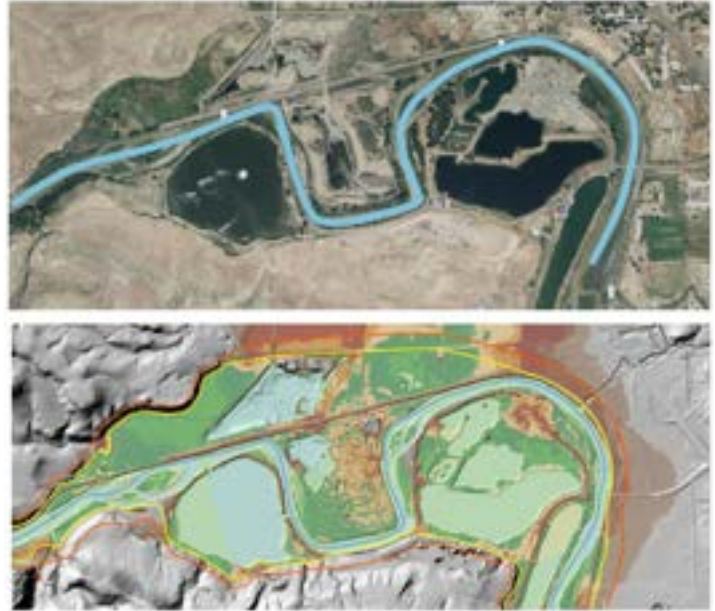
Figure 6-21. Gunnison River at Whitewater with high sinuosity around gravel ponds.

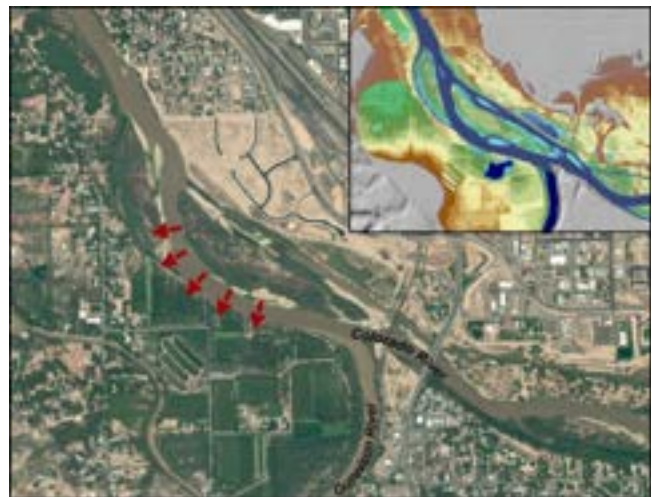
Figure 6-22. Direction of channel migration into Bureau of Reclamation habitat property.

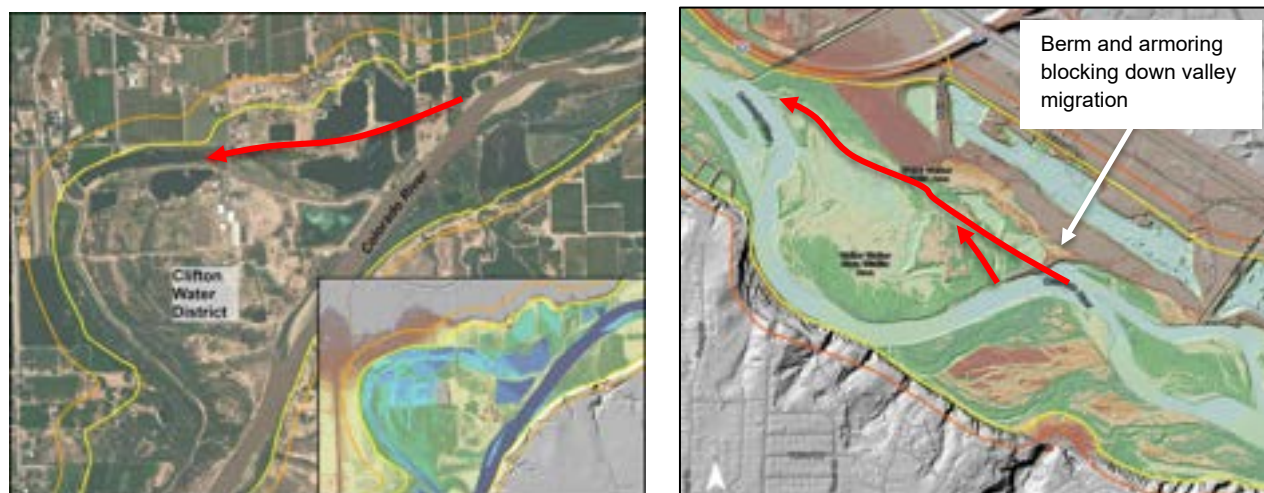
Figure 6-23. Two side channel restoration project candidates. (Left) Reconnection of side channel through gravel ponds and to former side channel around the Clifton Water and Sanitation District Facility. (Right) Side channel restoration and berm removal at Walter Walker State Wildlife Area. Red arrows indicate potential side channel flow paths.

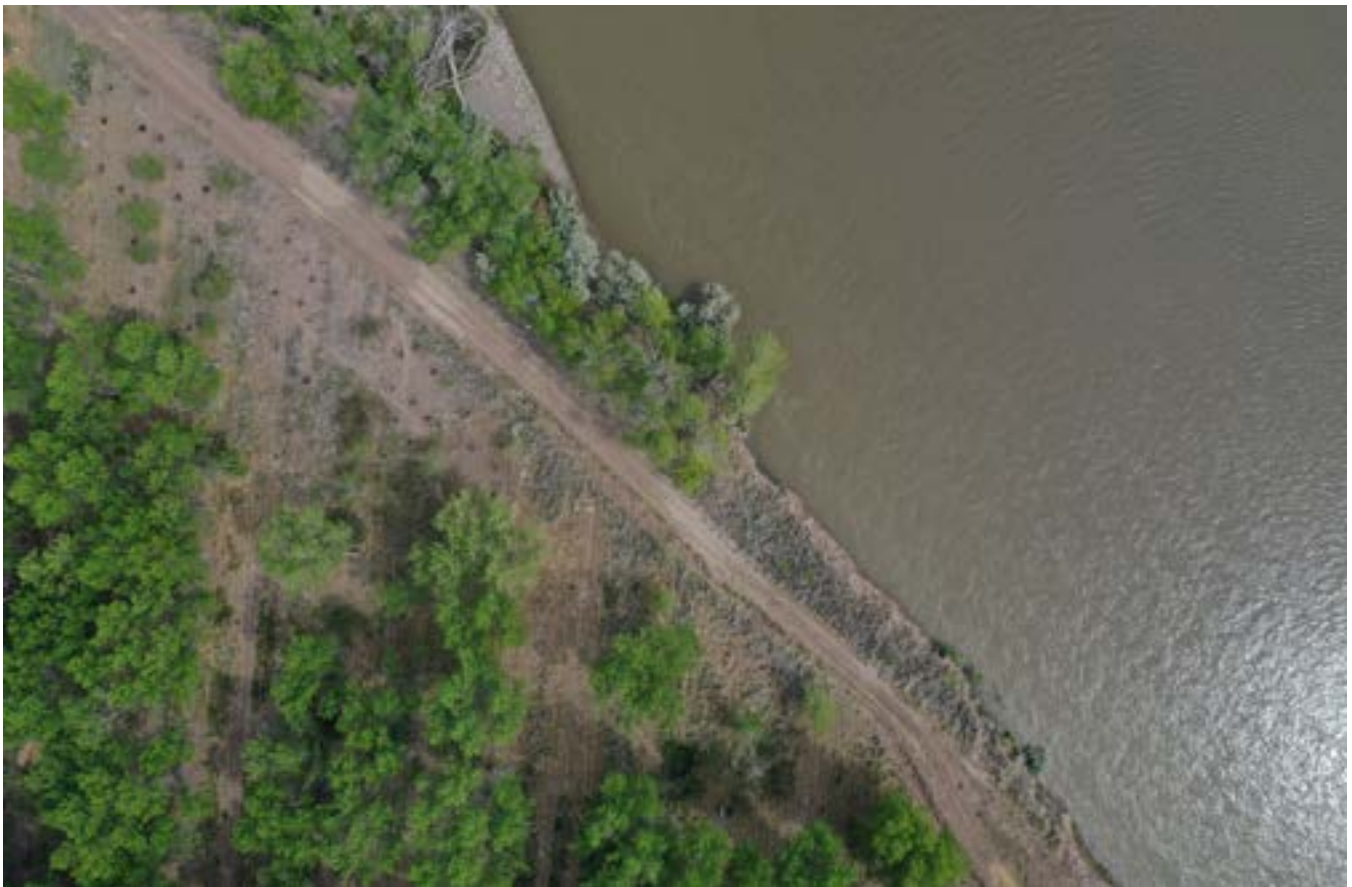
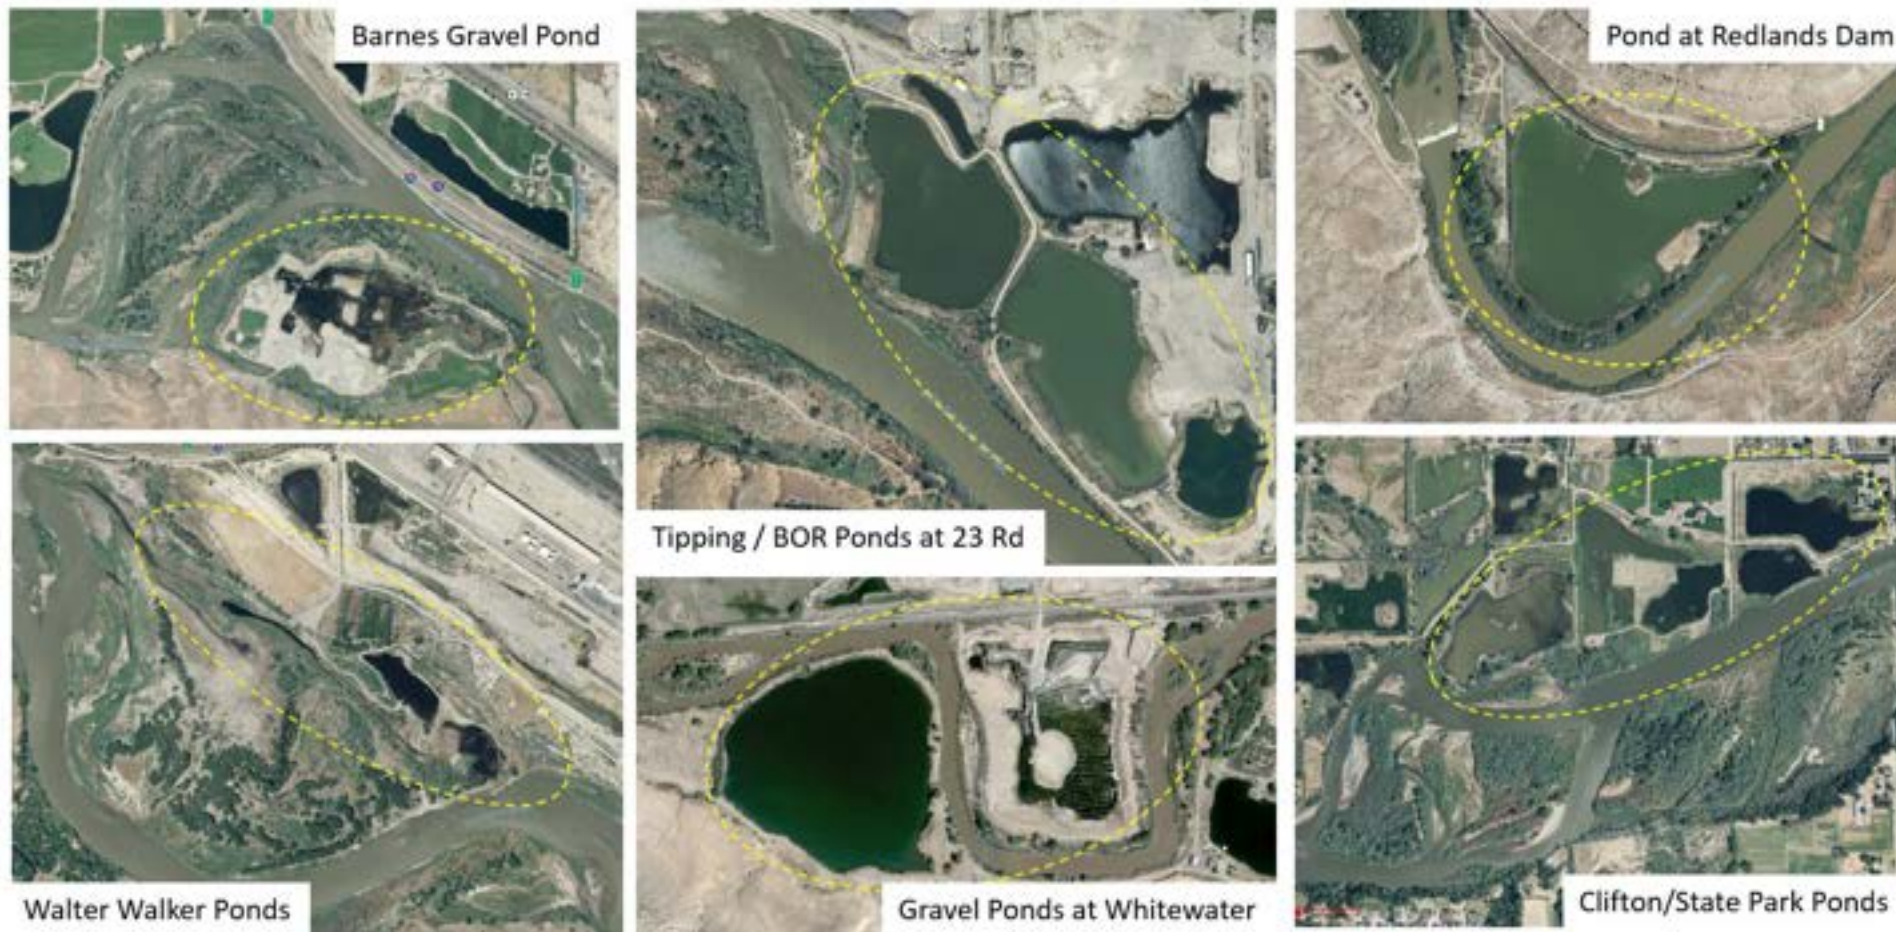
Figure 6-24. Potential floodplain and gravel pond sites where floodplain reconnection and restoration would be beneficial from a channel migration perspective.
